Pre-Construction Dilapidation Report of
The Surrounding Public area to 2 Lanceley Pl, Artarmon

Prepared For: Delta Pty Ltd

Project No.: 12.7.143.1

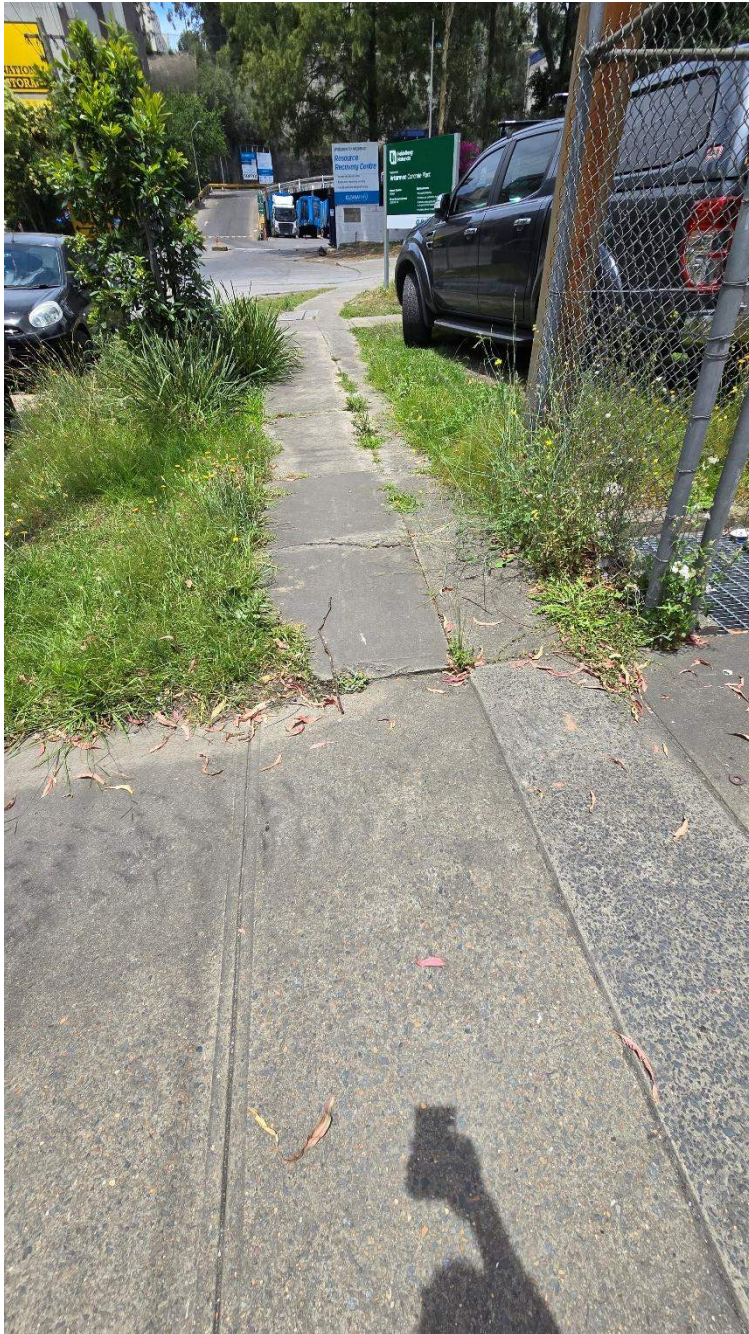
1. Photo: Cracks observed (1) - Crocodile cracking developing - Refer to satellite image for location reference
 2. Photo: Cracks observed (2) - Tree root infestation in footpath - Refer to satellite image for location reference

Figure 1 Cracks observed (1) - Crocodile cracking developing

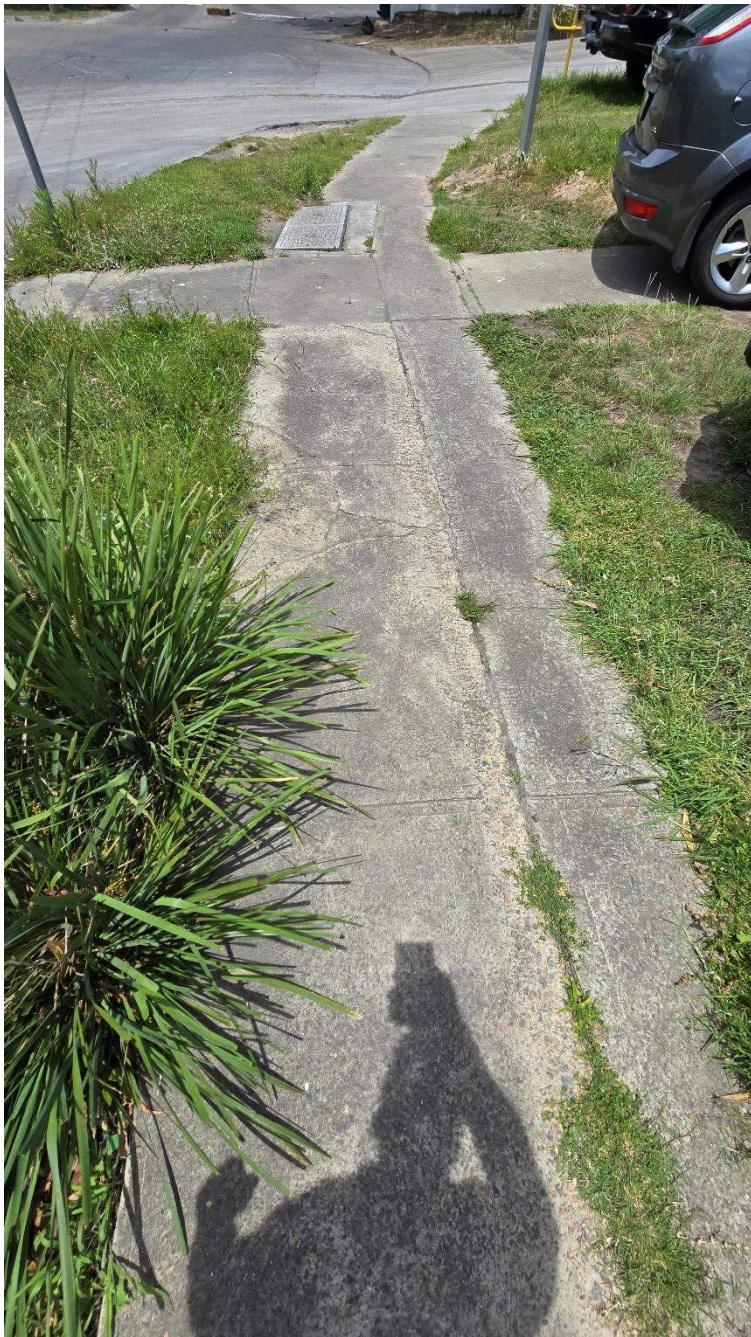
Figure 2 Cracks observed (2) - Tree root infestation in footpath

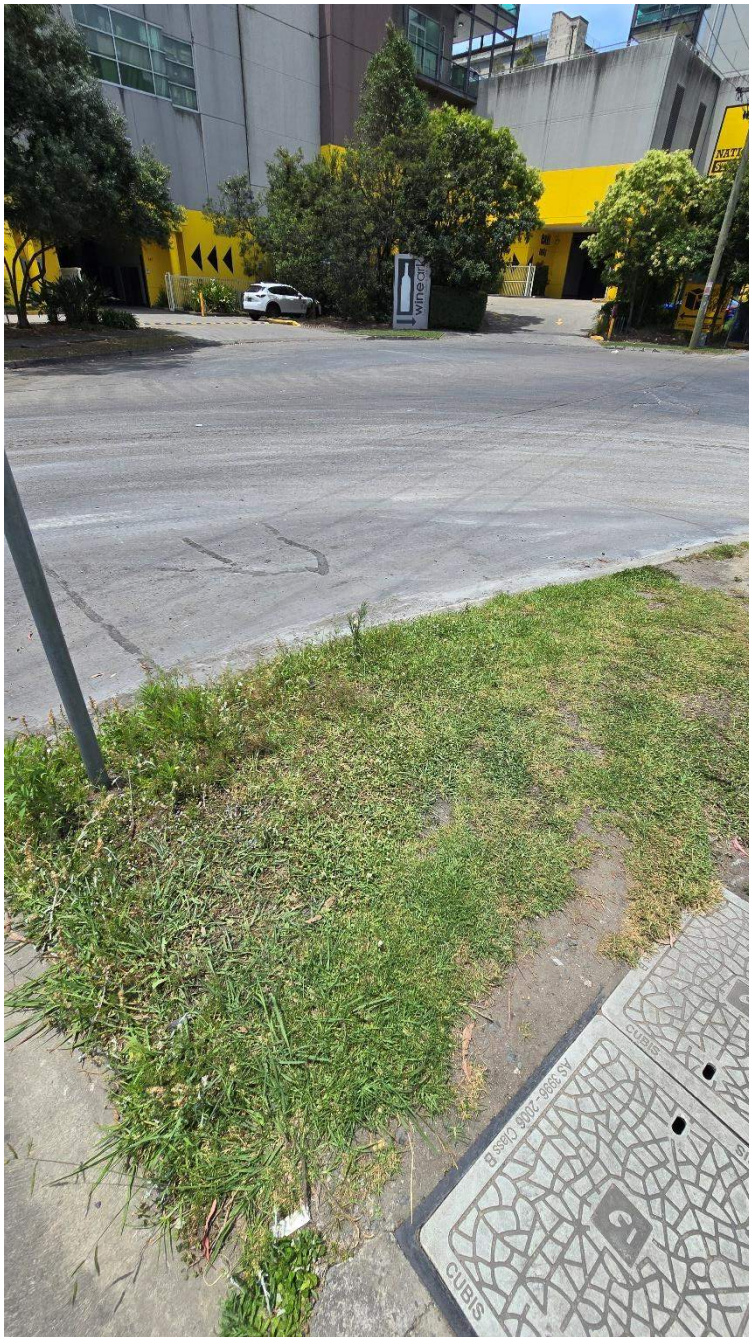
3. Photo: Cracks observed (3) - Substantial cracking in pavement - Refer to satellite image for location reference
 4. Photo: Cracks observed (4) - Crocodile cracking developing - Refer to satellite image for location reference

Figure 3 Cracks observed (3) - Substantial cracking in pavement

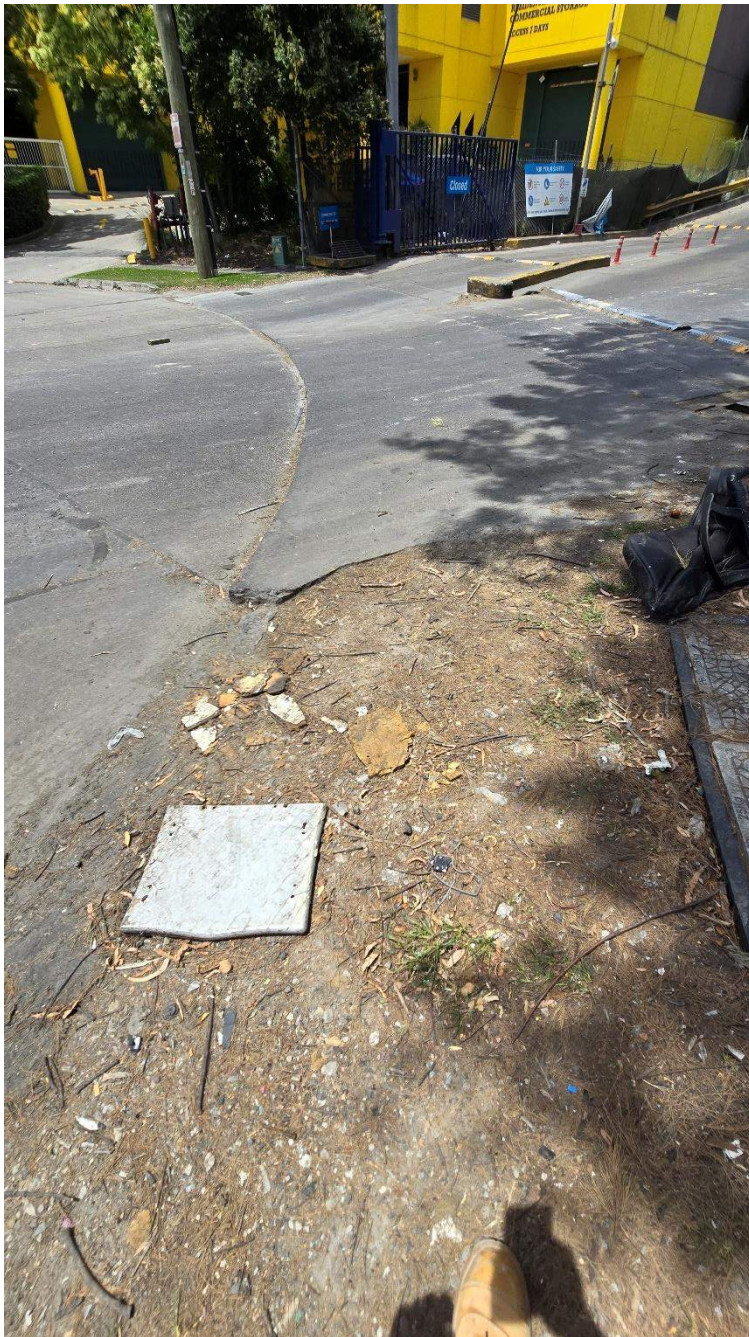
Figure 4 Cracks observed (4) - Crocodile cracking developing

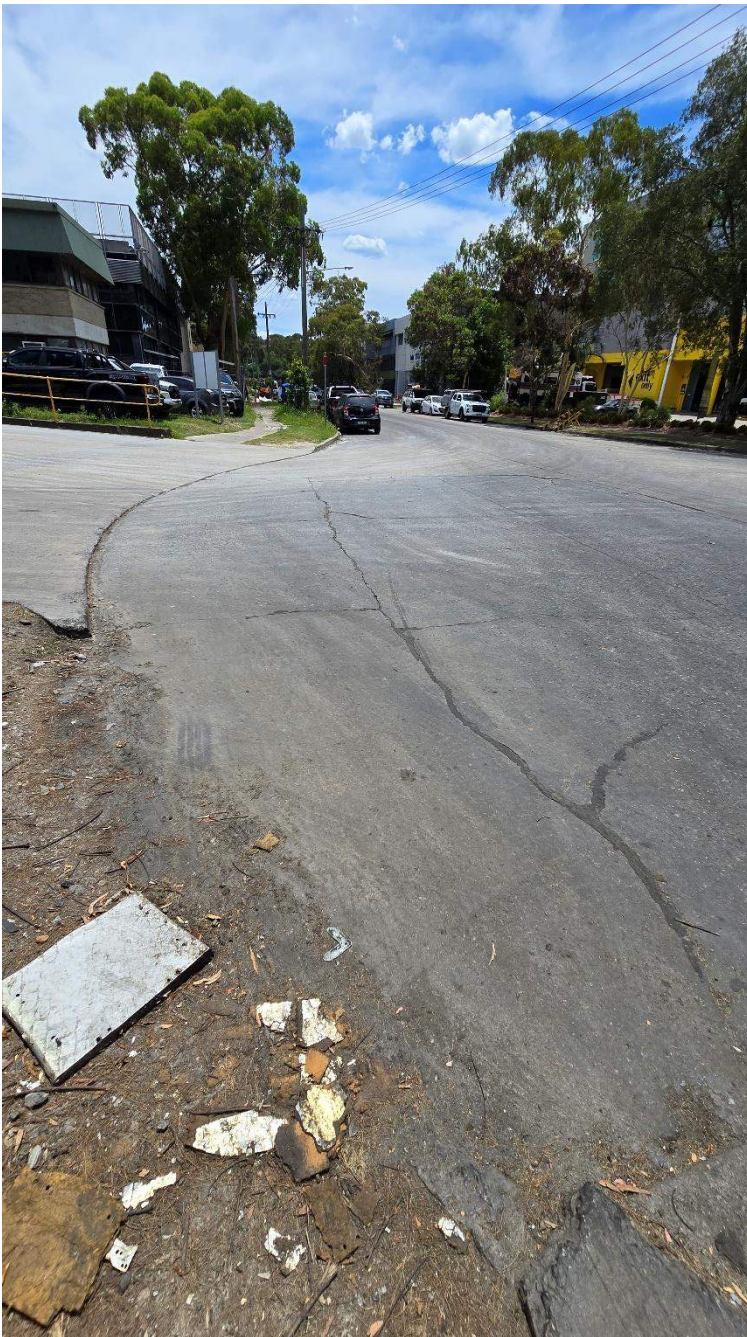
5. Photo: Cracks observed (5) - General wear and tear of driveway - Refer to satellite image for location reference
 6. Photo: Cracks observed (6) - Large surface breaks road - Refer to satellite image for location reference

Figure 5 Cracks observed (5) - General wear and tear of driveway

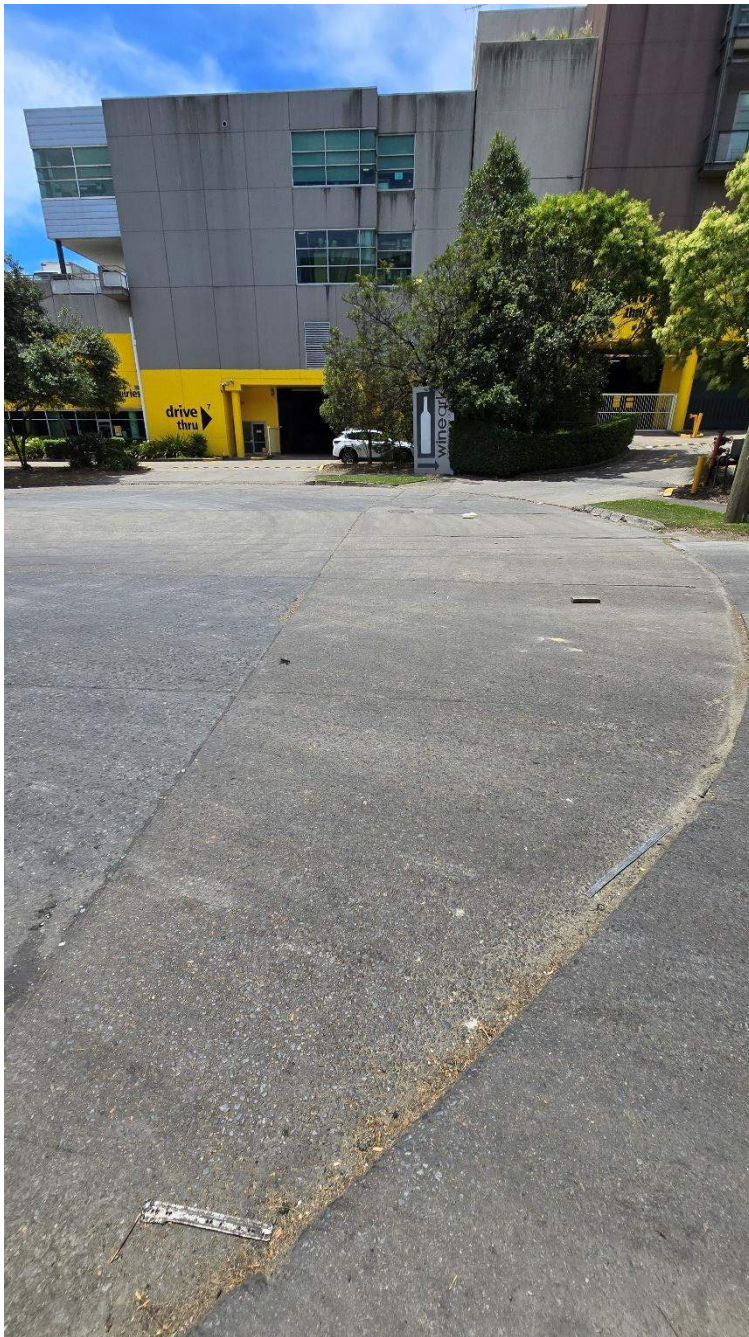
Figure 6 Cracks observed (6) - Large surface breaks road

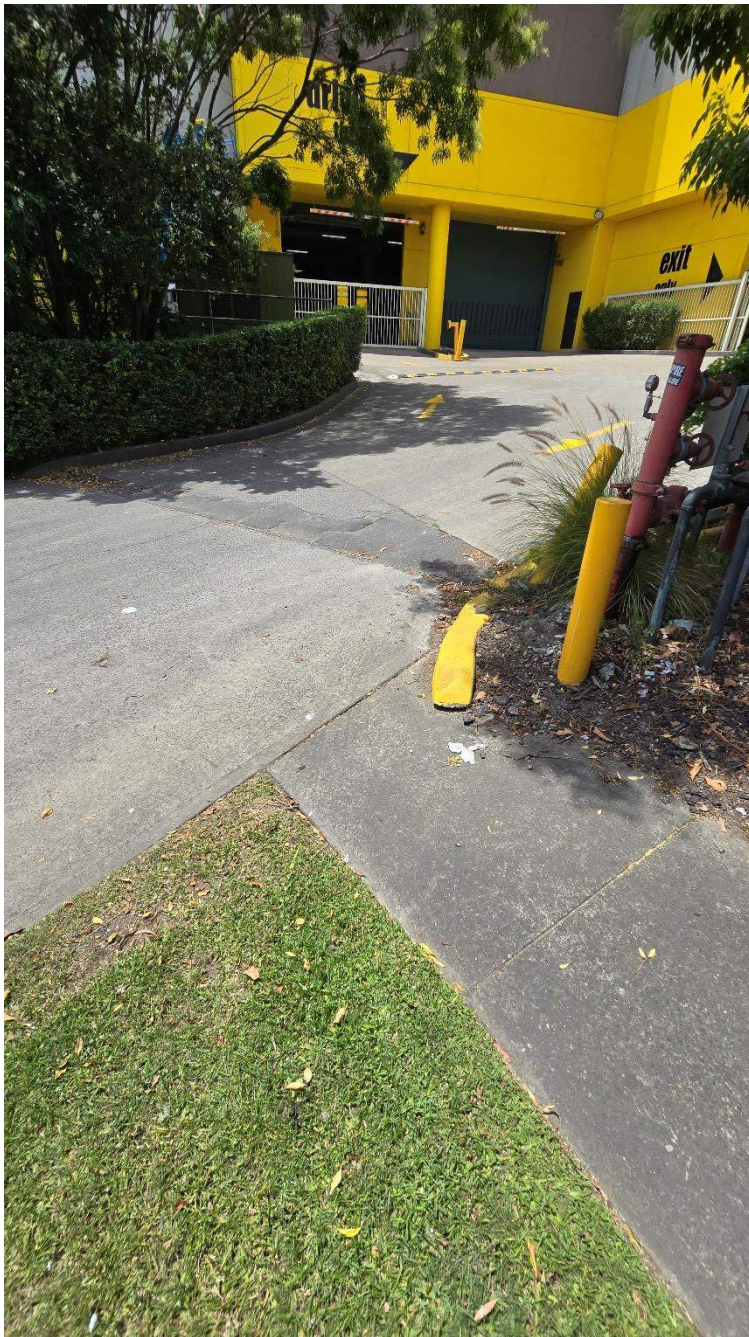
7. Photo: Cracks observed (7) - Large surface breaks driveway - Refer to satellite image for location reference
 8. Photo: Cracks observed (8) - Large surface breaks driveway - Refer to satellite image for location reference

Figure 7 Cracks observed (7) - Large surface breaks driveway

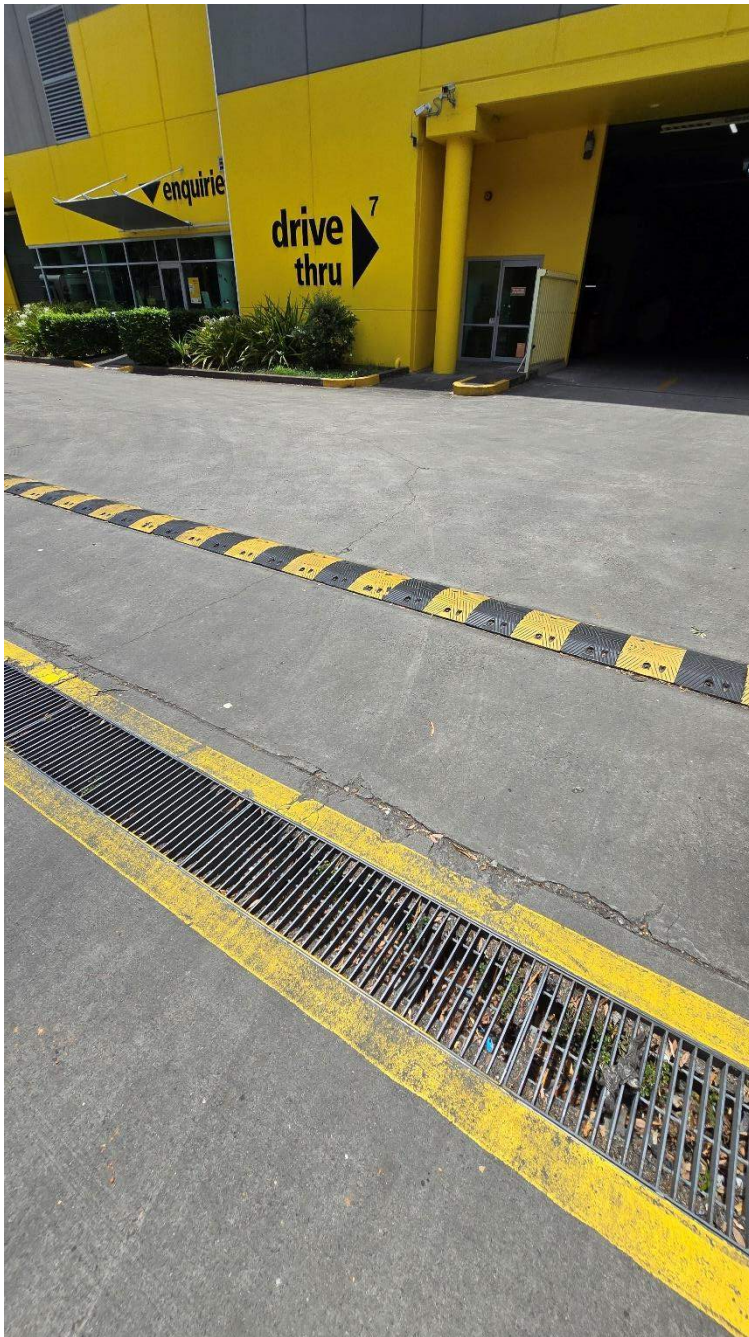
Figure 8 Cracks observed (8) - Large surface breaks driveway

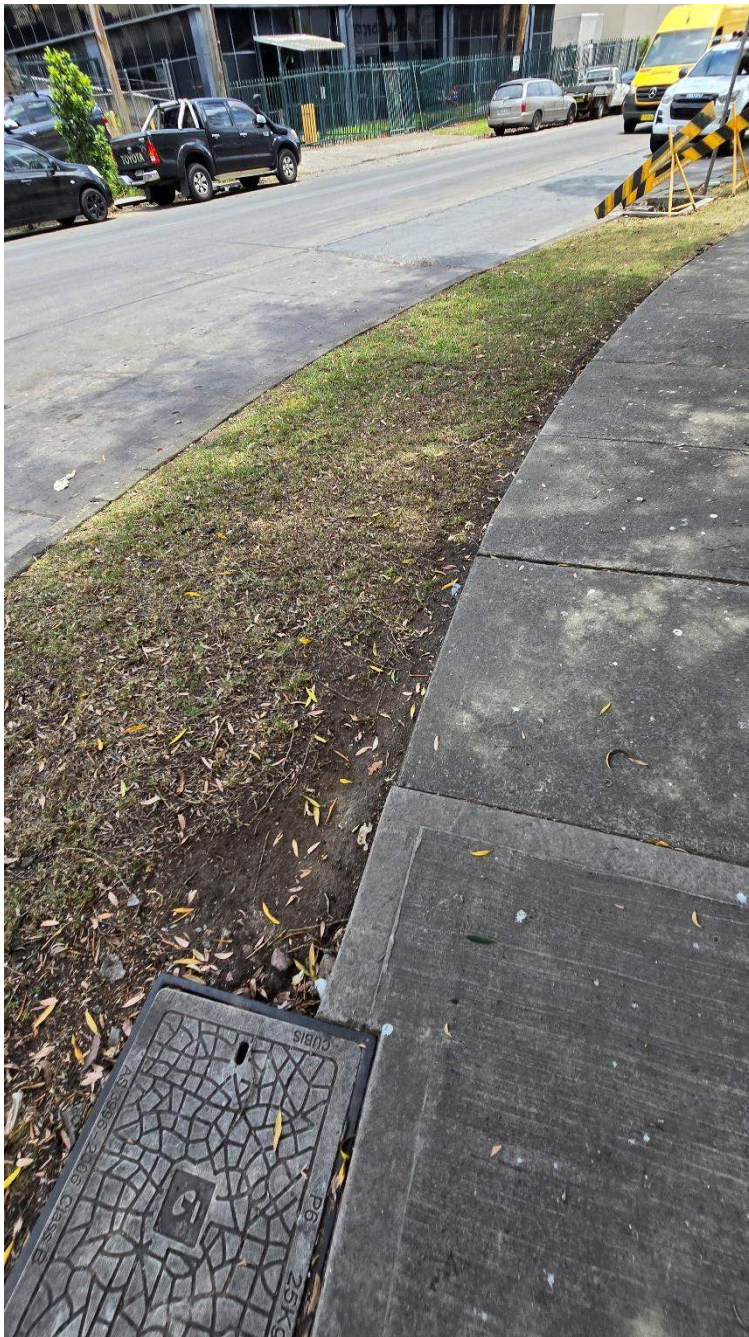
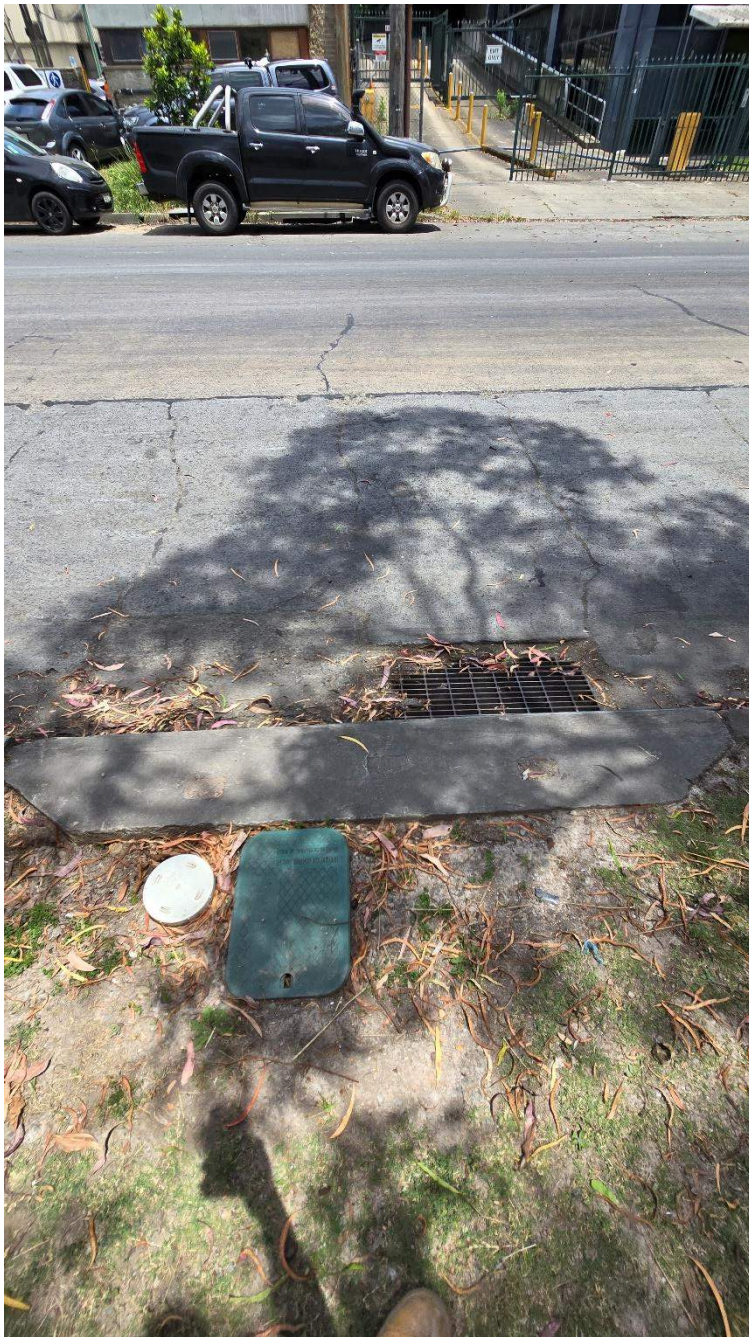
9. Photo: Cracks observed (9, 10) - Large surface breaks footpath - Refer to satellite image for location reference
 10. Photo: Cracks observed (11) - Crocodile cracking developing - Refer to satellite image for location reference

Figure 9 Cracks observed (9, 10) - Large surface breaks footpath

Figure 10 Cracks observed (9, 10) - Large surface breaks footpath

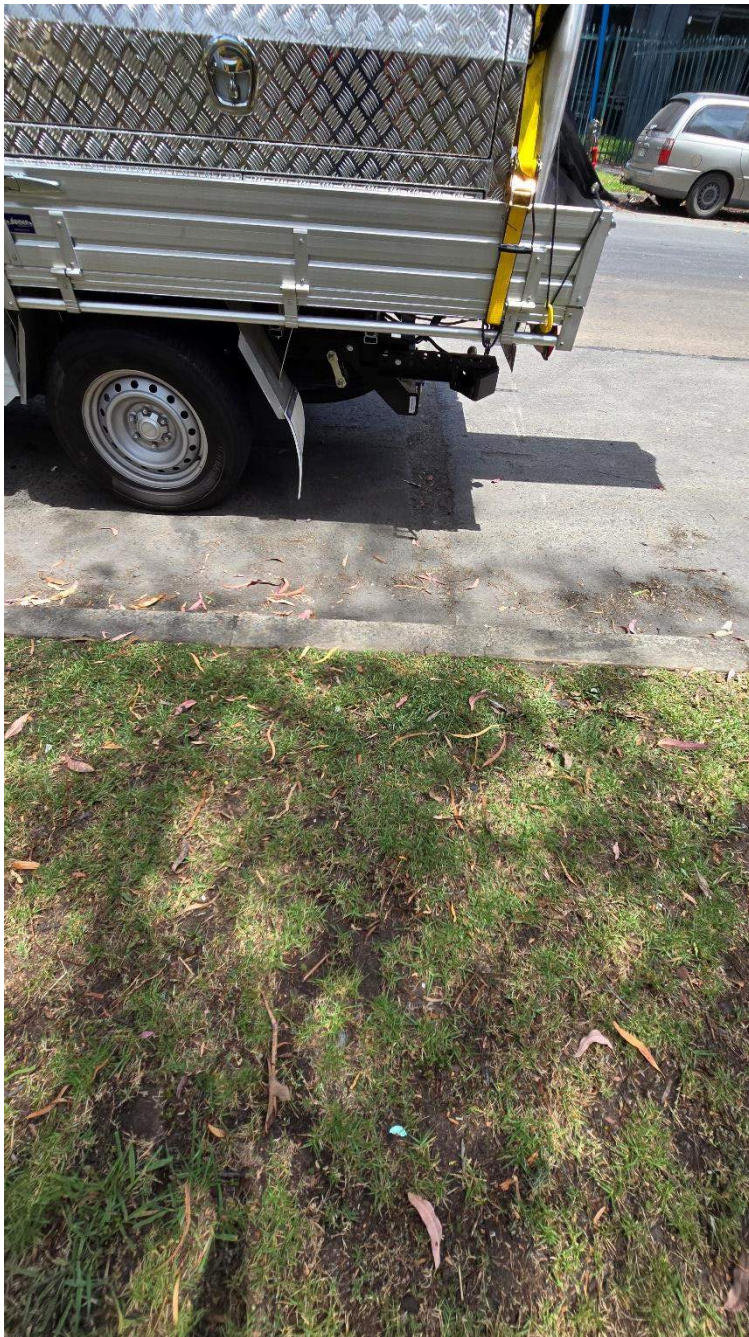
Figure 11 Cracks observed (11) - Crocodile cracking developing

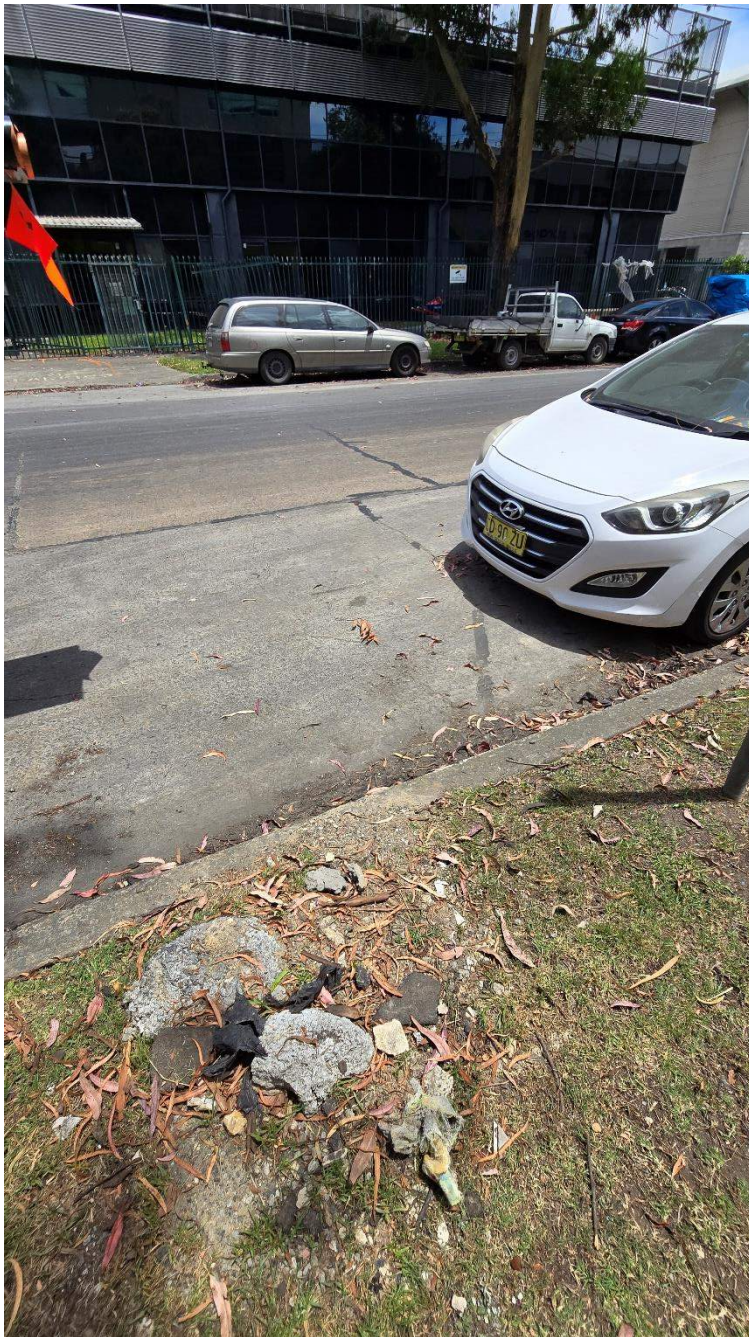
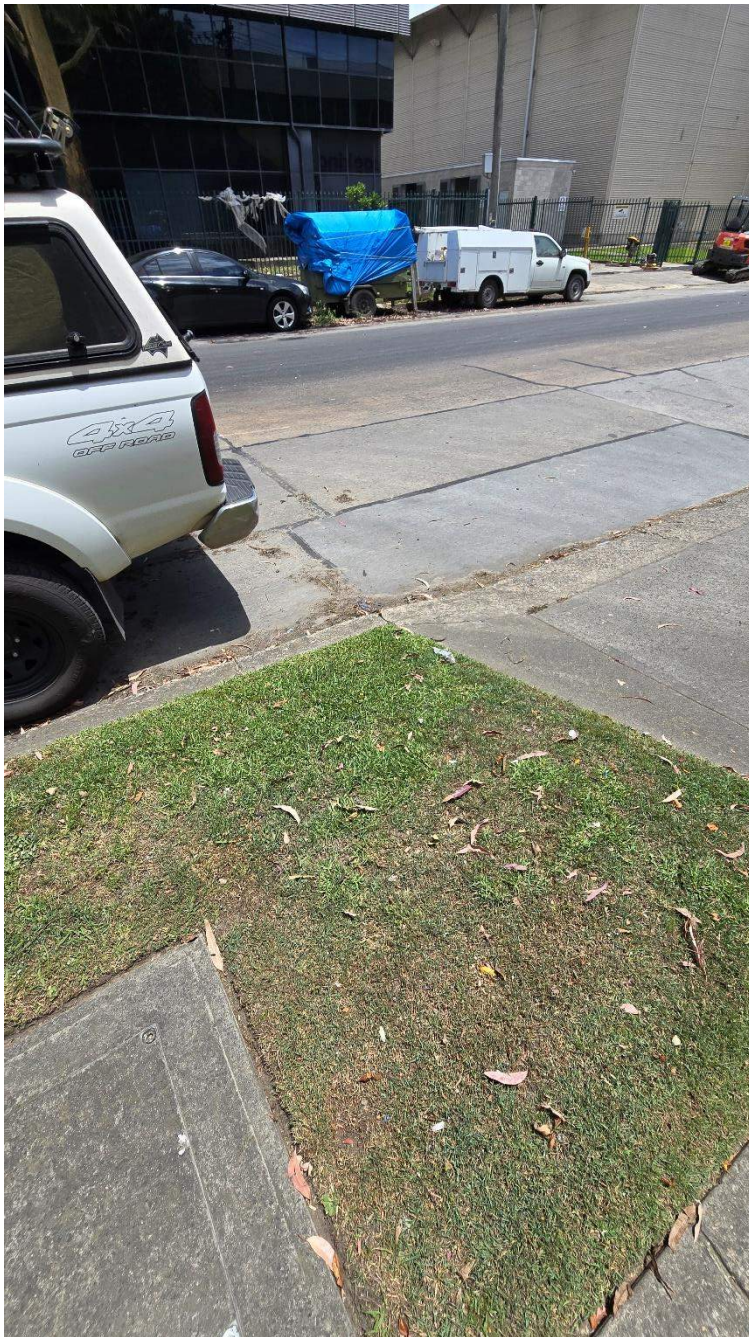
11. Photo: Cracks observed (12, 13, 14) - Large surface breaks road - Refer to satellite image for location reference
 12. Photo: Cracks observed (15) - Large surface breaks driveway - Refer to satellite image for location reference

Figure 12 Cracks observed (12, 13, 14) - Large surface breaks road

Figure 13 Cracks observed (12, 13, 14) - Large surface breaks road

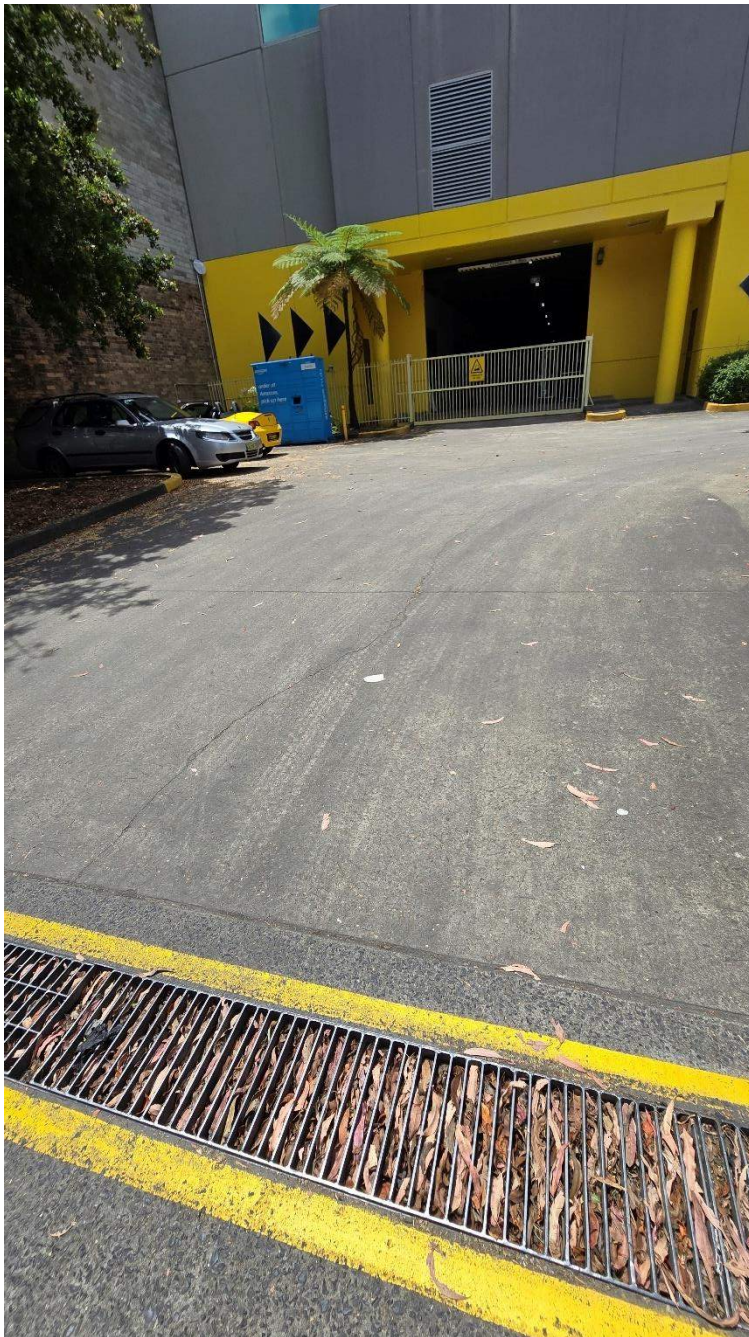
Figure 14 Cracks observed (15) - Large surface breaks driveway

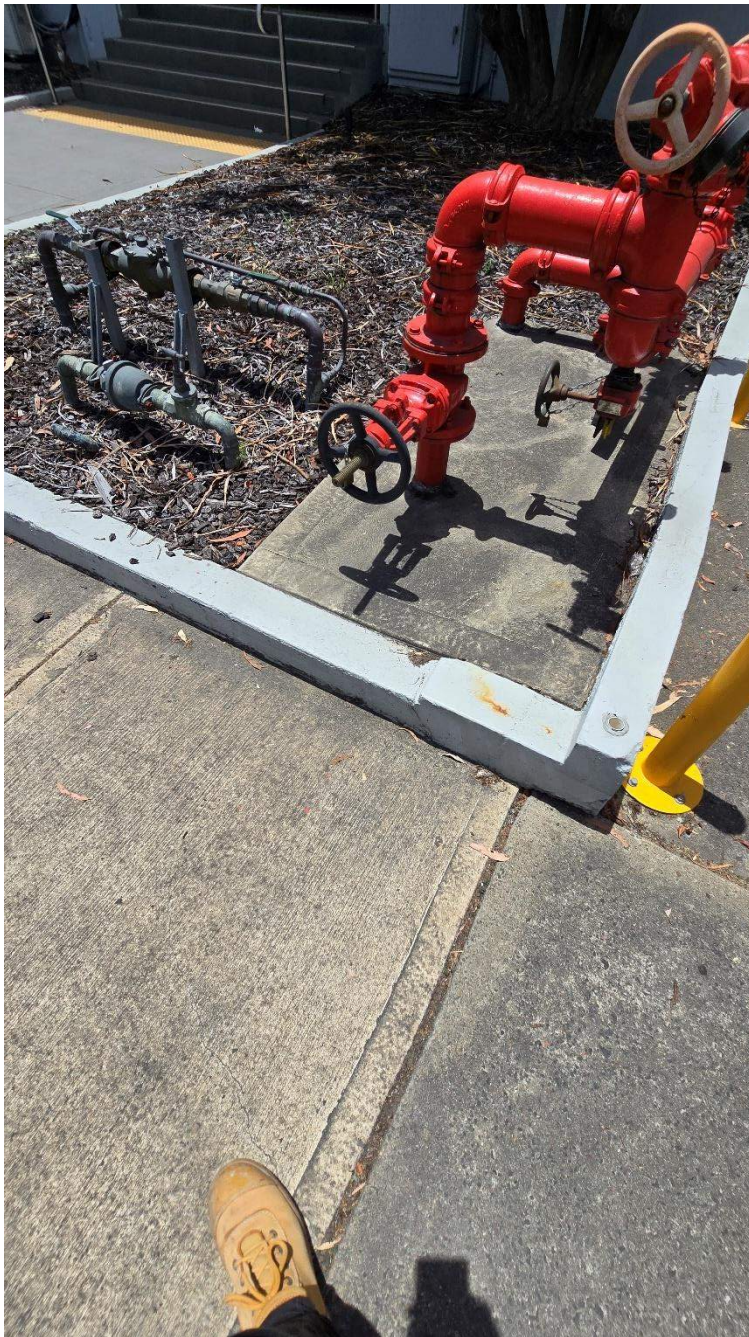
13. Photo: Cracks observed (16) - Misalignment of retaining wall - Refer to satellite image for location reference
 14. Photo: Cracks observed (17) - Cracks in brick feature - Refer to satellite image for location reference

Figure 15 Cracks observed (16) - Misalignment of retaining wall

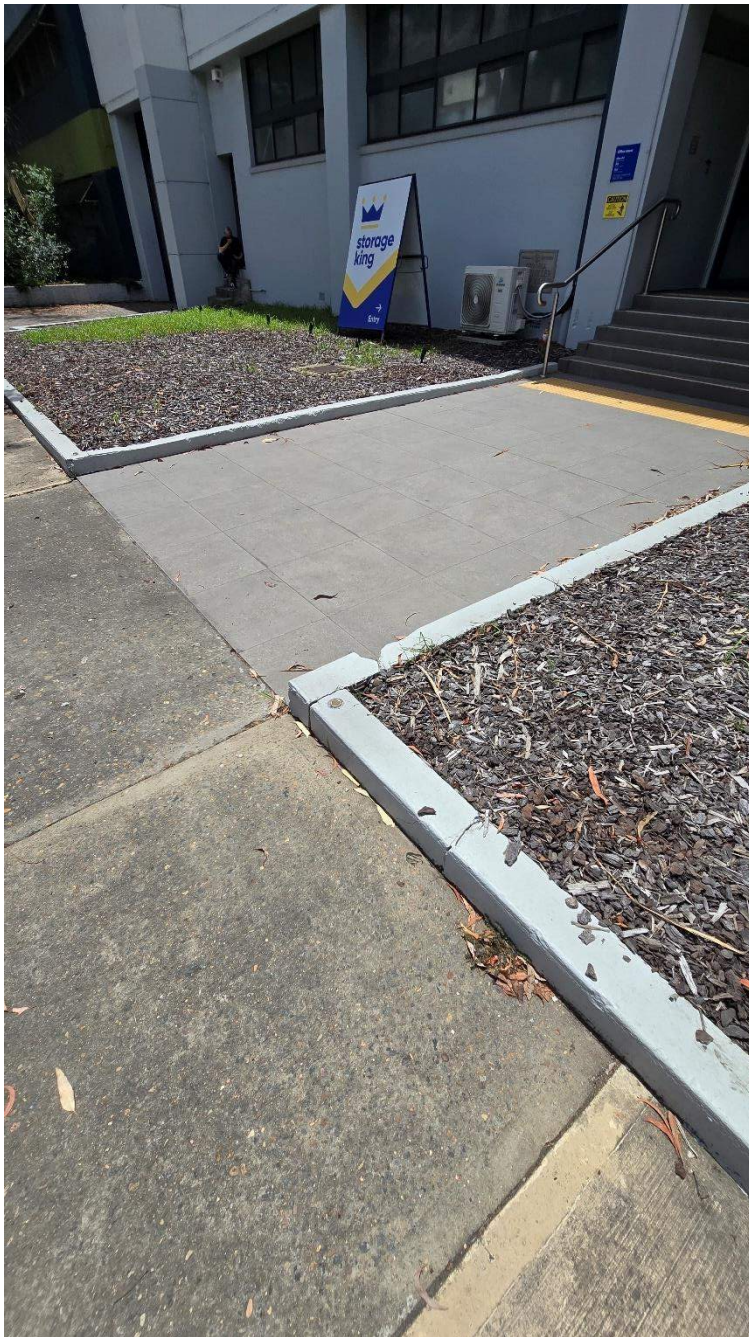
Figure 16 Cracks observed (17) - Cracks in brick feature

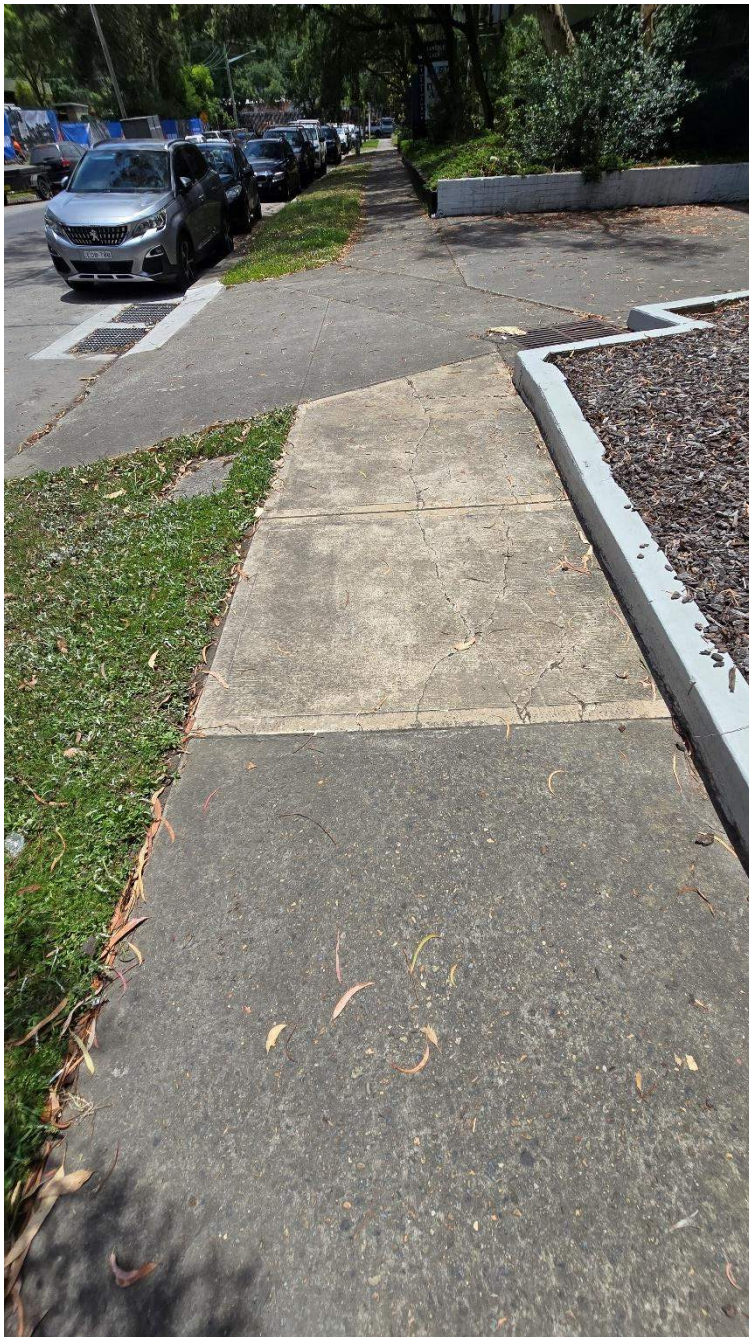
15. Photo: Cracks observed (18) - Footpath concrete cracks - Refer to satellite image for location reference
 16. Photo: Cracks observed (19) - Poor condition of driveway, cracks and joints - Refer to satellite image for location reference

Figure 17 Cracks observed (18) - Footpath concrete cracks

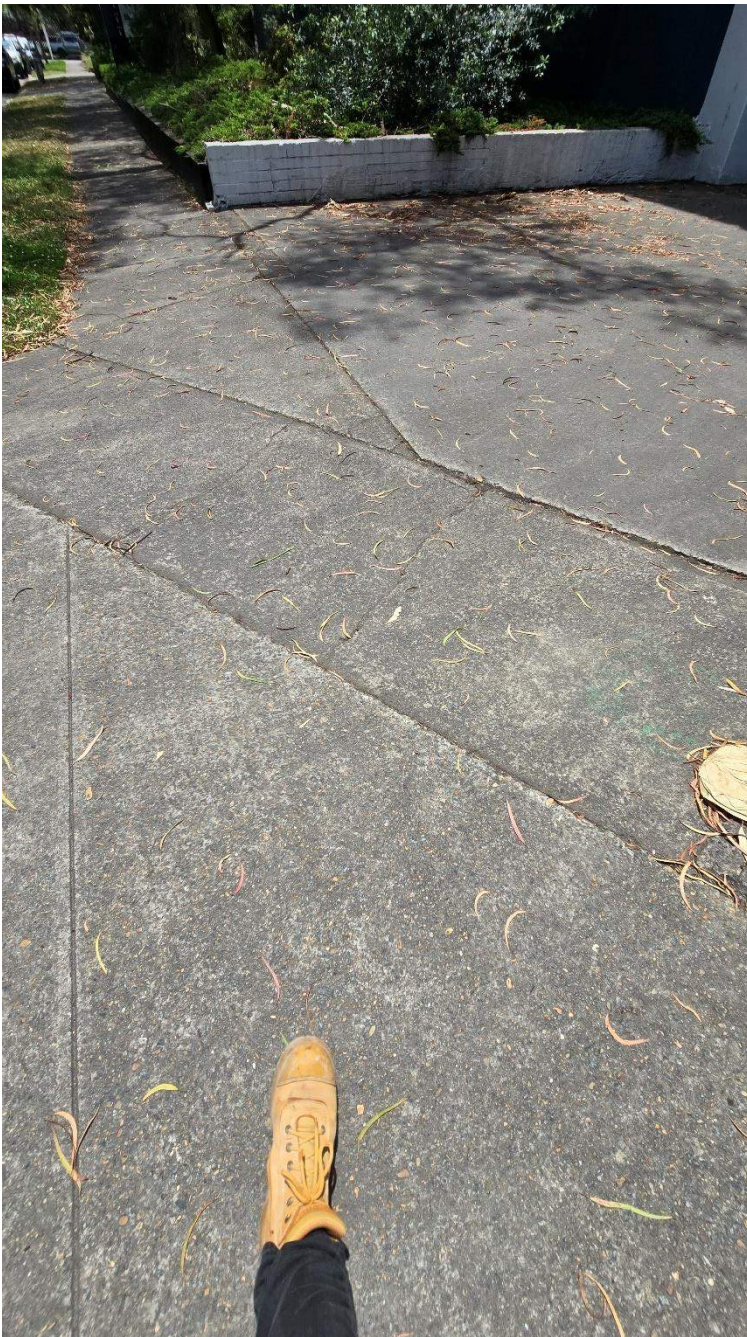
Figure 18 Cracks observed (19) - Poor condition of driveway, cracks and joints

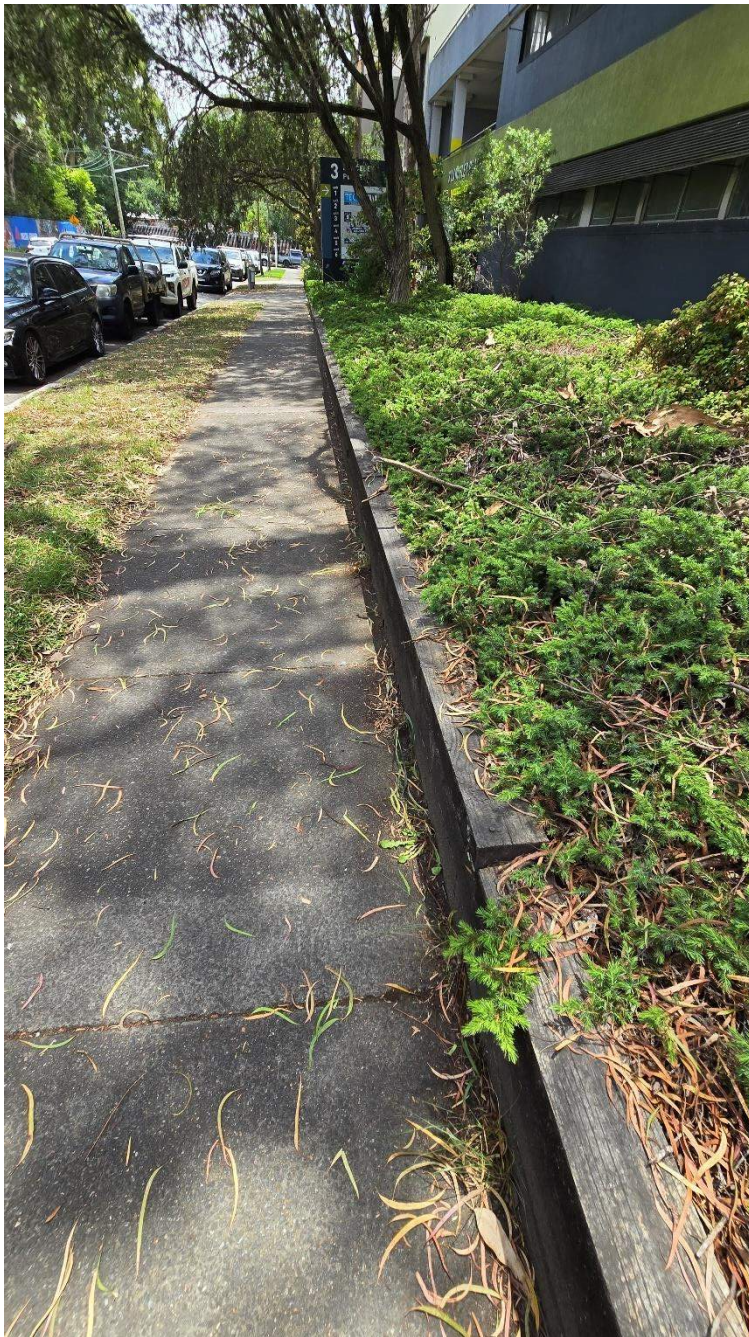
17. Photo: Cracks observed (20) - Retaining wall leaning outwards - Refer to satellite image for location reference
 18. Photo: Cracks observed (21) - Crocodile cracking in driveway - Refer to satellite image for location reference

Figure 19 Cracks observed (20) - Retaining wall leaning outwards

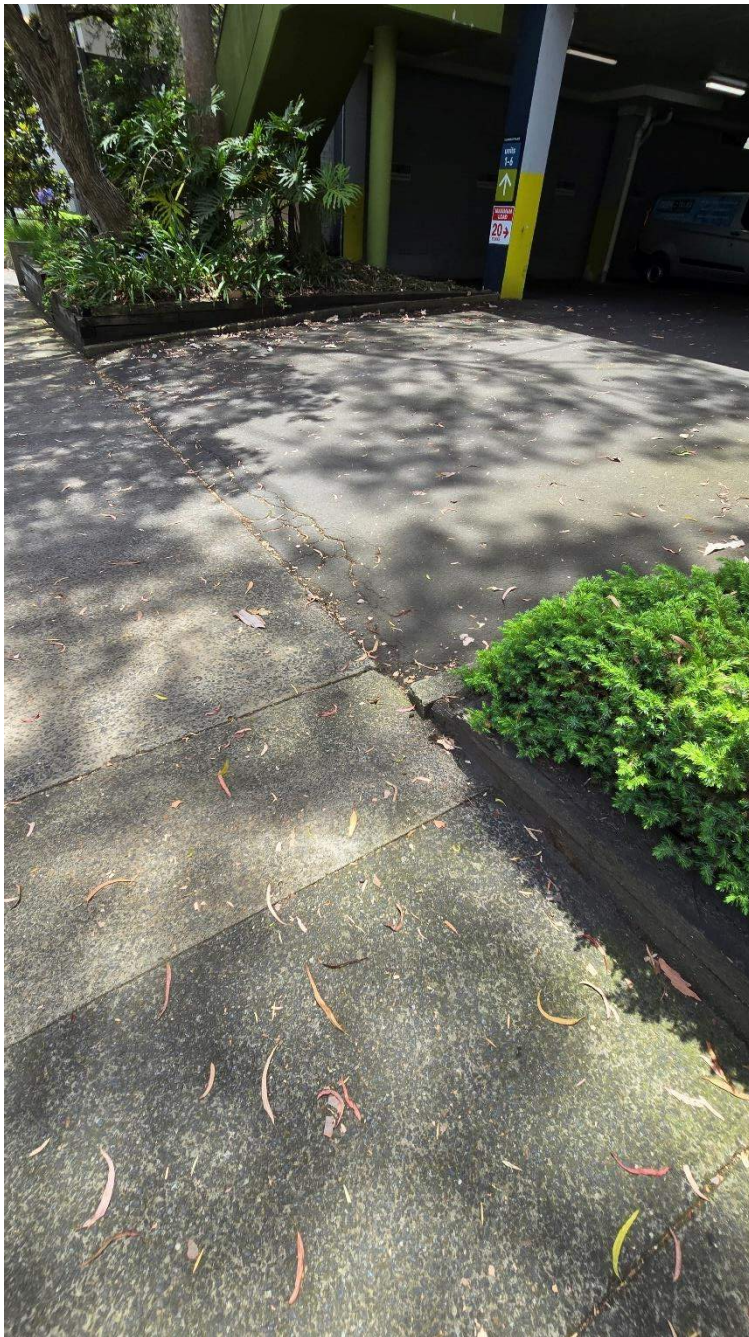
Figure 20 Cracks observed (21) - Crocodile cracking in driveway

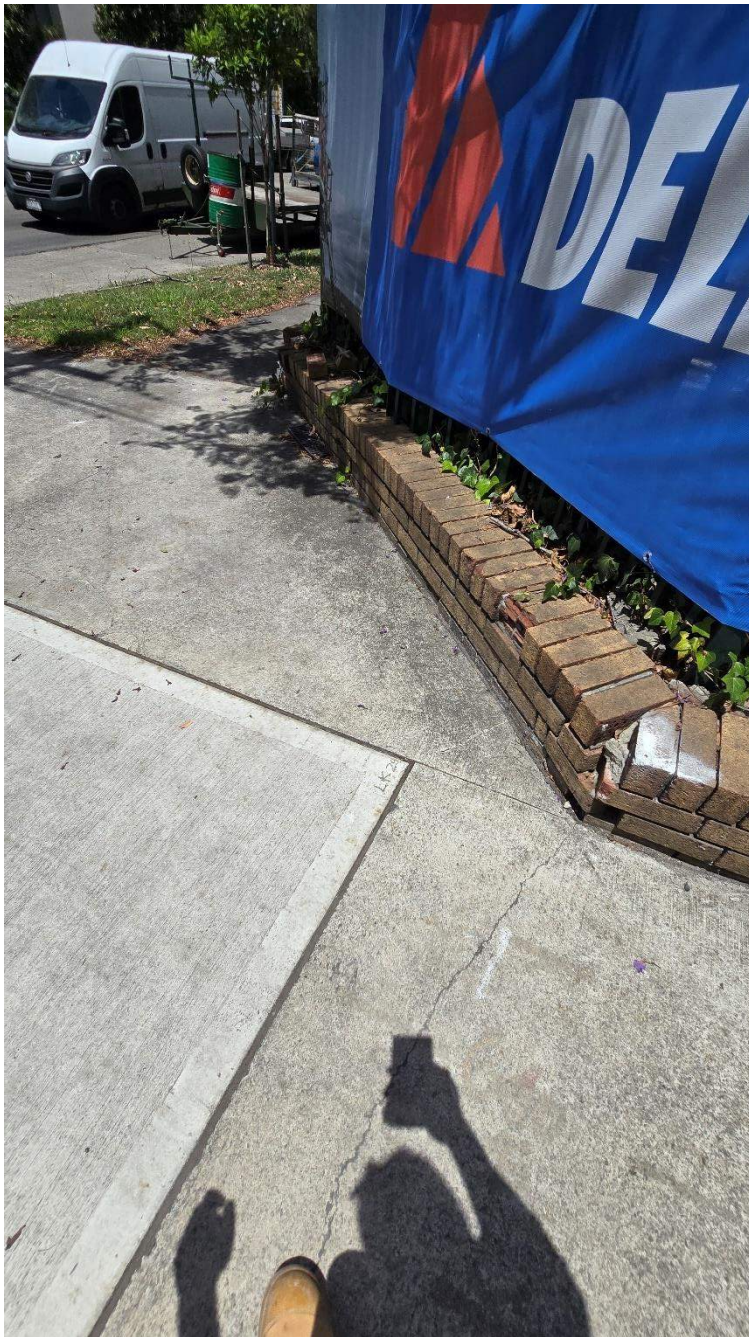
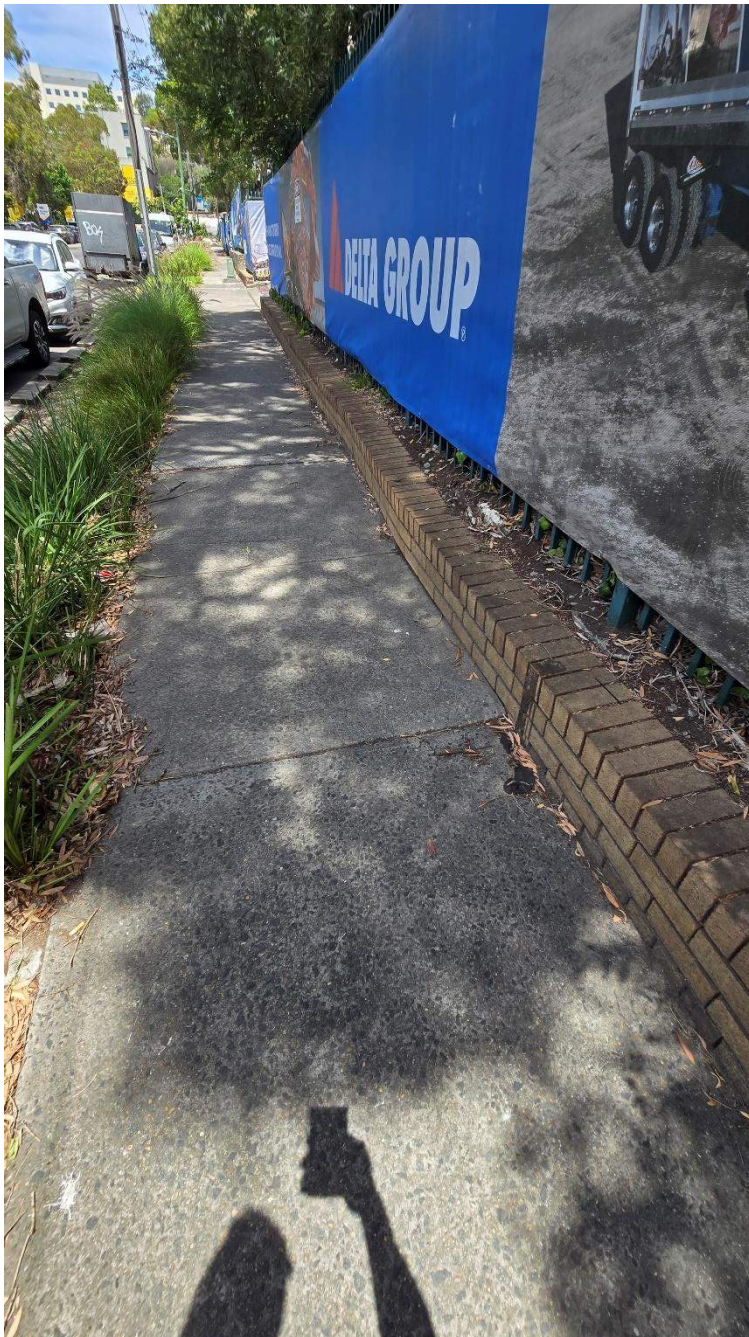
19. Photo: Cracks observed (22, 23) - Retaining wall leaning outwards - Refer to satellite image for location reference
 20. Photo: Cracks observed (24) - Footpath cracking - Refer to satellite image for location reference

Figure 21 Cracks observed (22, 23) - Retaining wall leaning outwards

Figure 22 Cracks observed (22, 23) - Retaining wall leaning outwards
