Pre-Construction Dilapidation Report of
The Surrounding Public area to 2 Lanceley Pl, Artarmon

Prepared For: Delta Pty Ltd

Project No.: 12.7.143.1

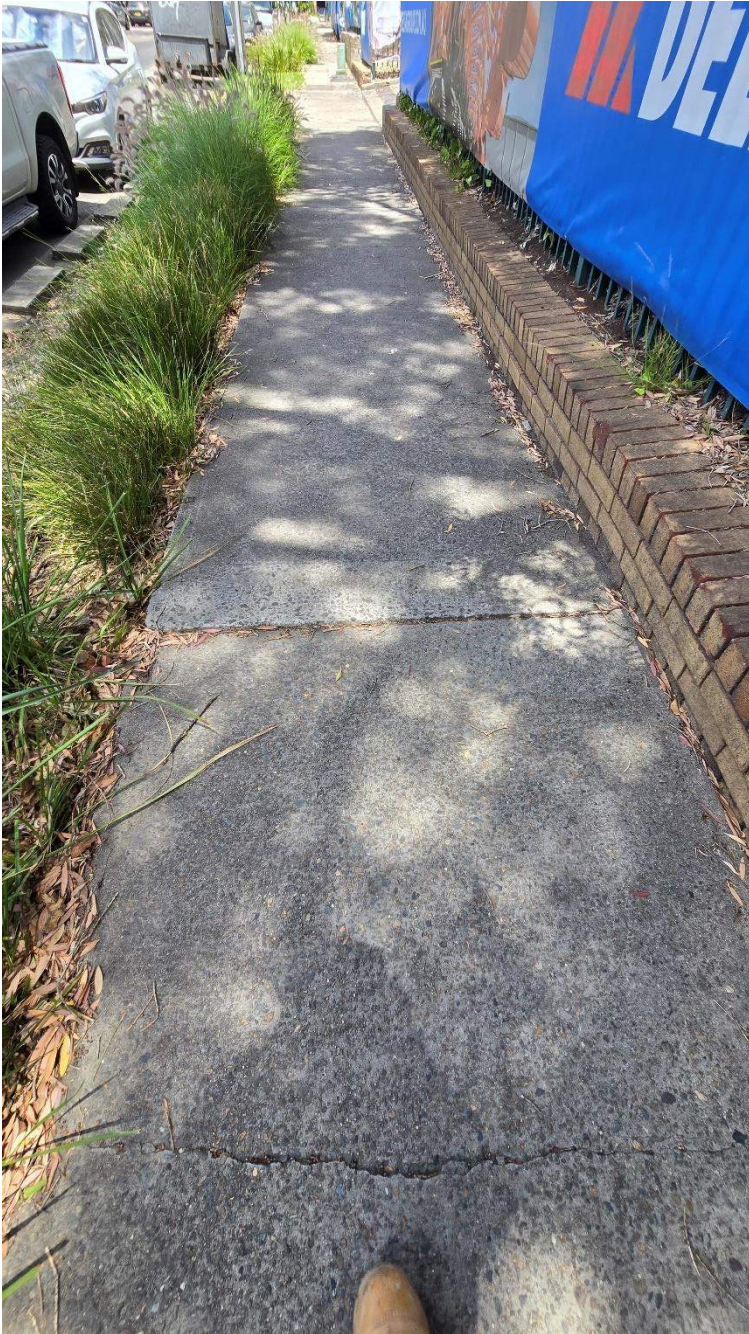
Figure 23 Cracks observed (24) - Footpath cracking

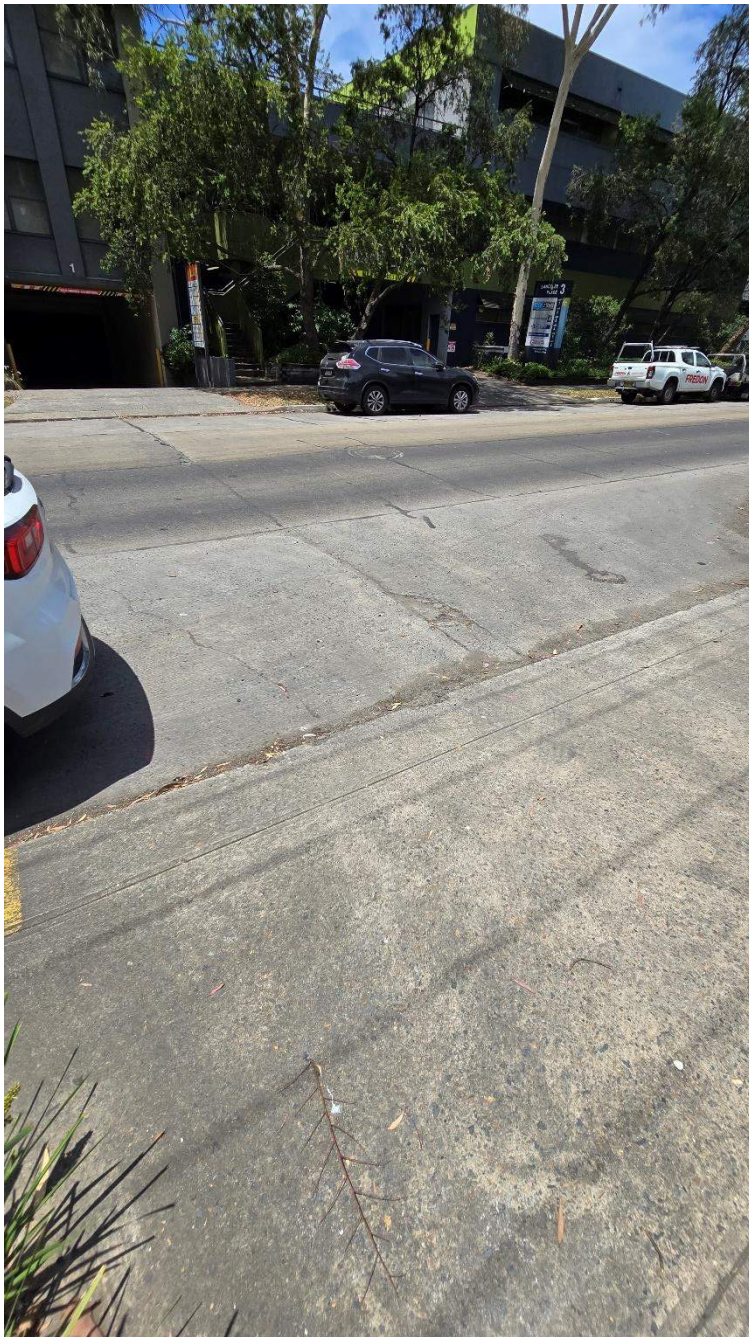
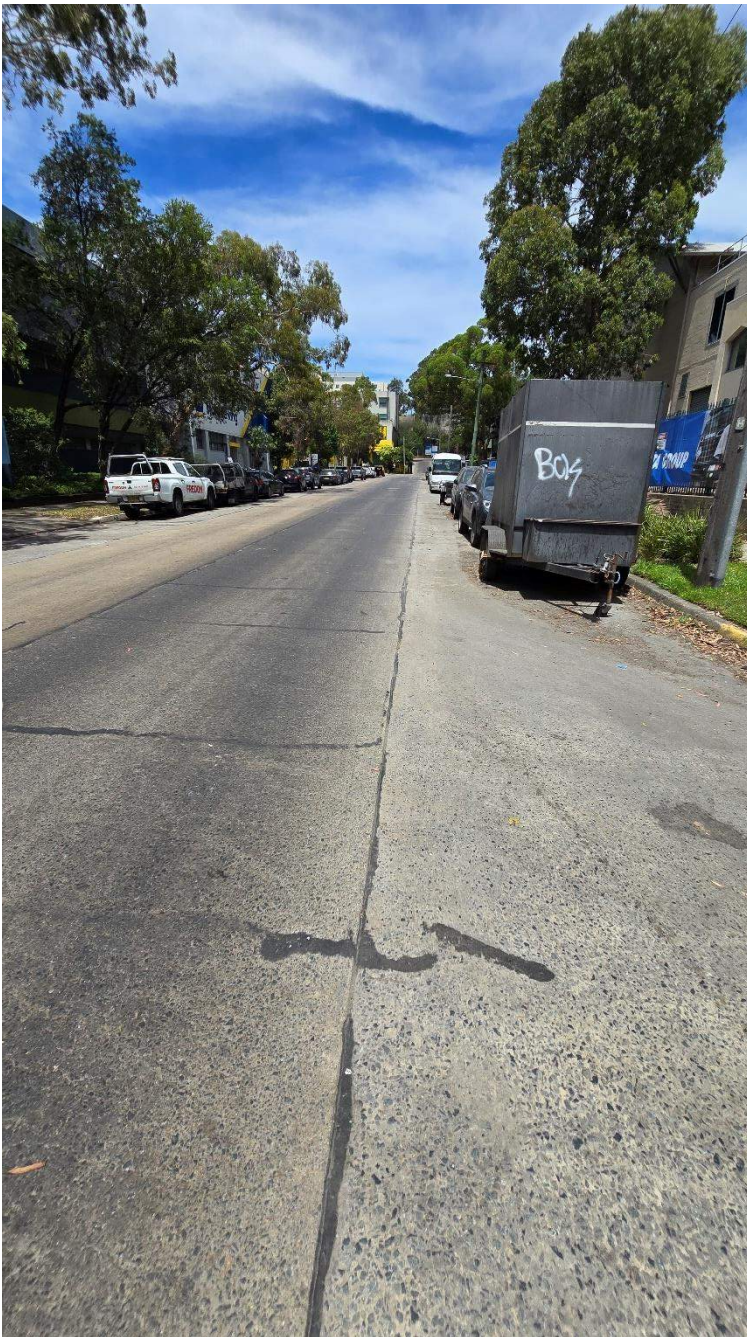
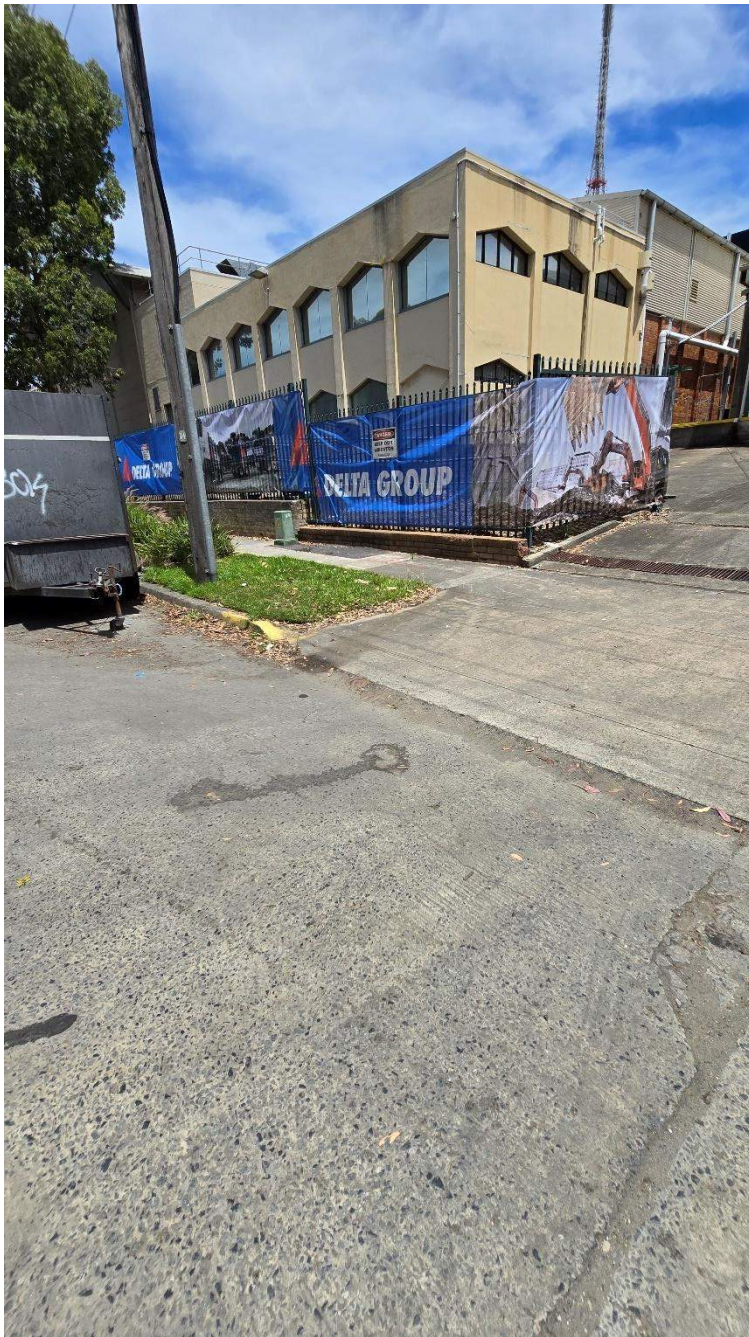
21. Photo: Cracks observed (25, 26, 27) - Road in poor condition, cracks and repairs observed throughout - Refer to satellite image for location reference

Figure 24 Cracks observed (25, 26, 27) - Road in poor condition, cracks and repairs observed throughout

Figure 25 Cracks observed (25, 26, 27) - Road in poor condition, cracks and repairs observed throughout

Figure 26 Cracks observed (25, 26, 27) - Road in poor condition, cracks and repairs observed throughout

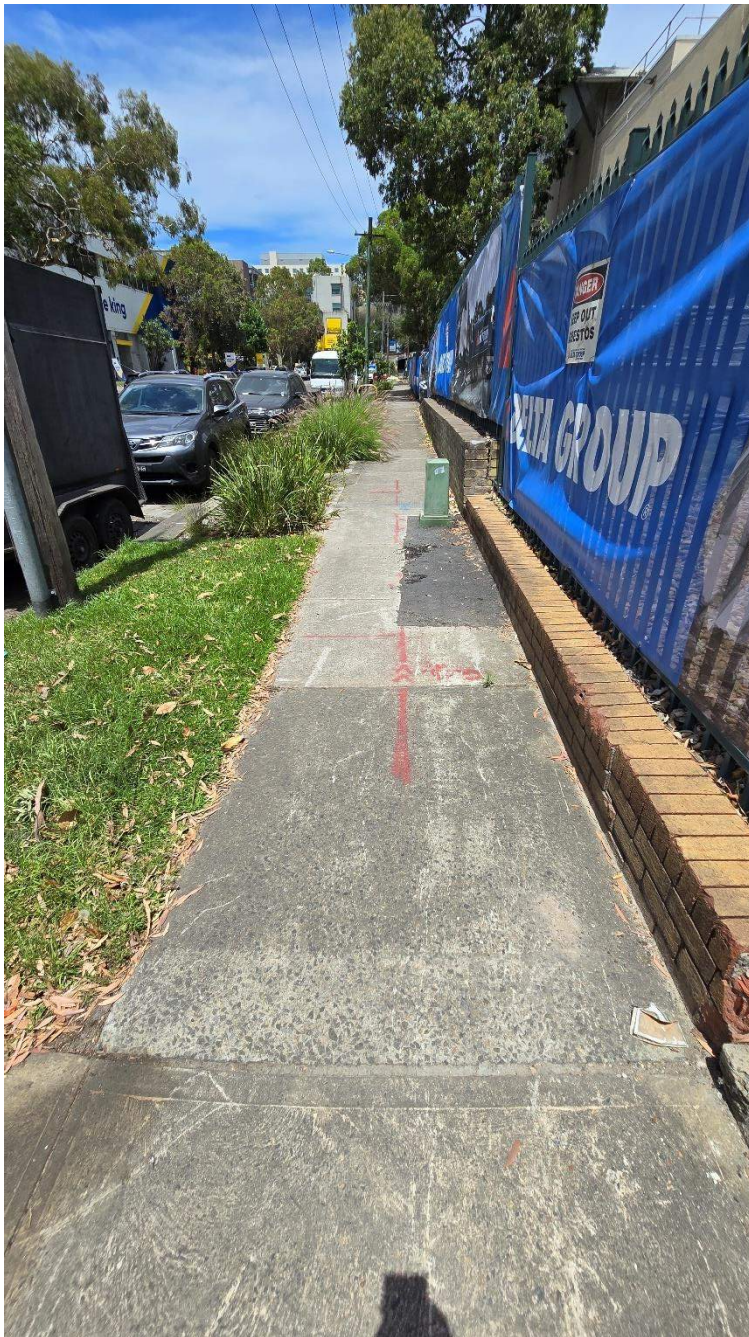
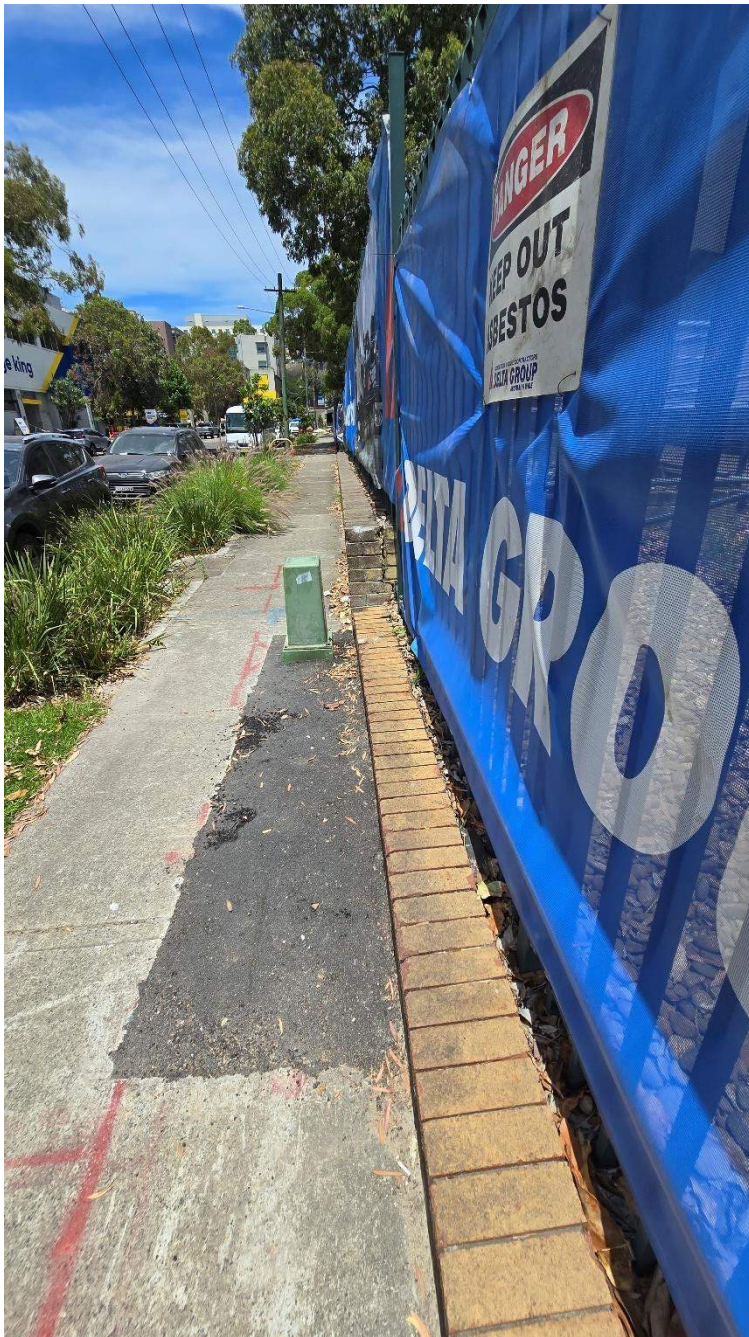
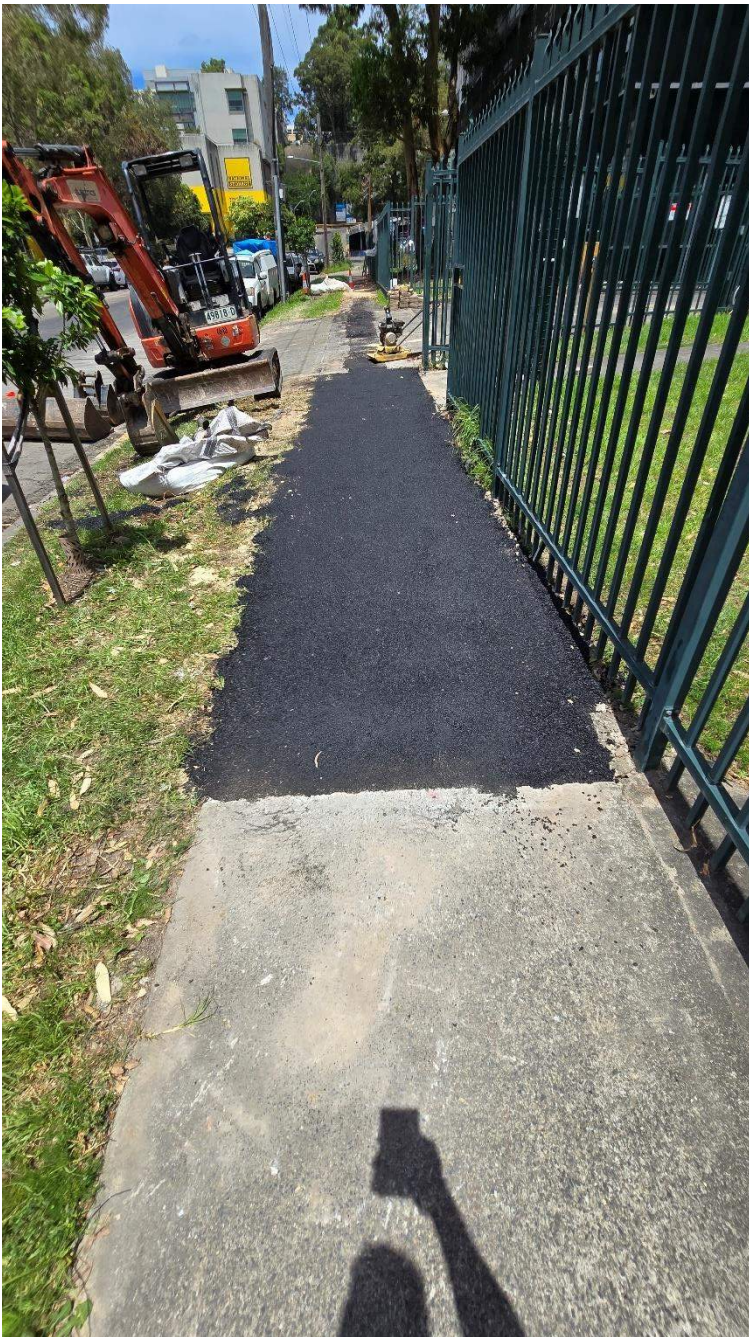
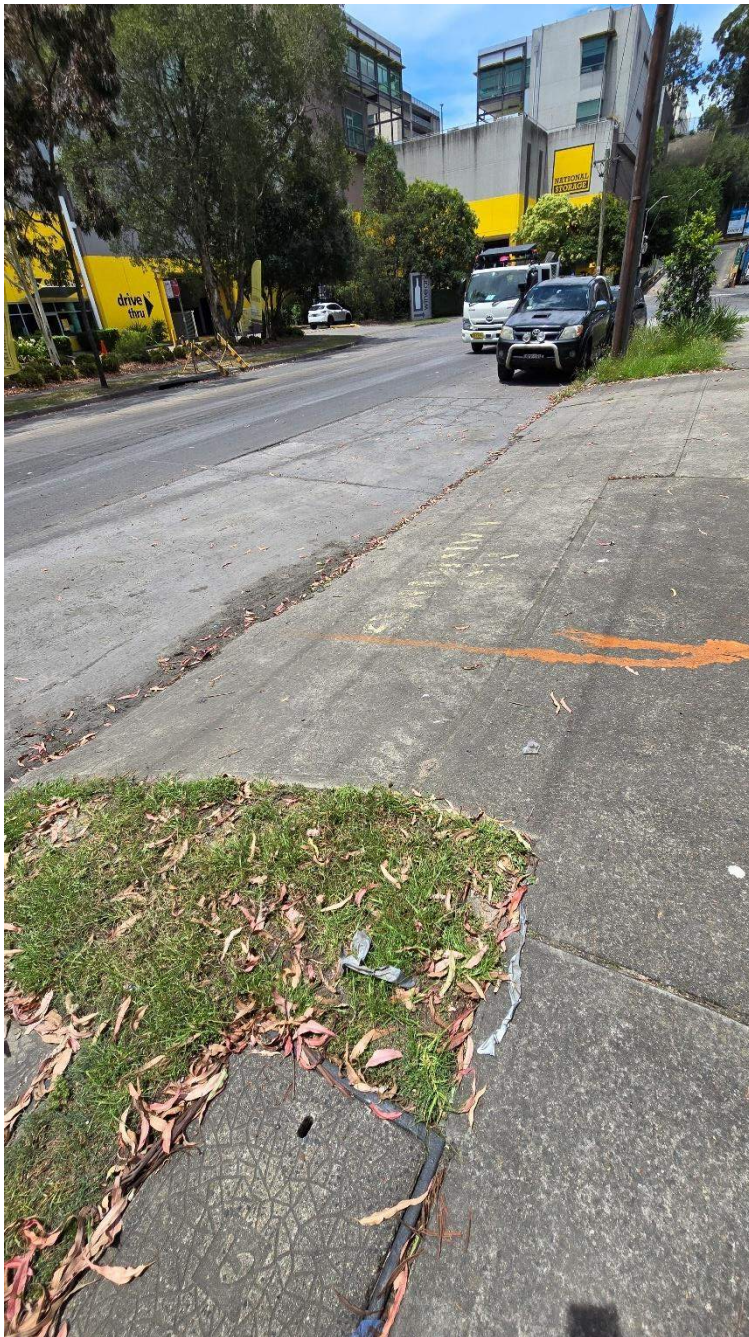
22. Photo: Cracks observed (28, 29, 30) - Footpath cracking - Refer to satellite image for location reference
-

Figure 27 Cracks observed (28, 29, 30) - Footpath cracking

Figure 28 Cracks observed (28, 29, 30) - Footpath cracking

Figure 29 Cracks observed (28, 29, 30) - Footpath cracking

Figure 30 Cracks observed (28, 29, 30) - Footpath cracking

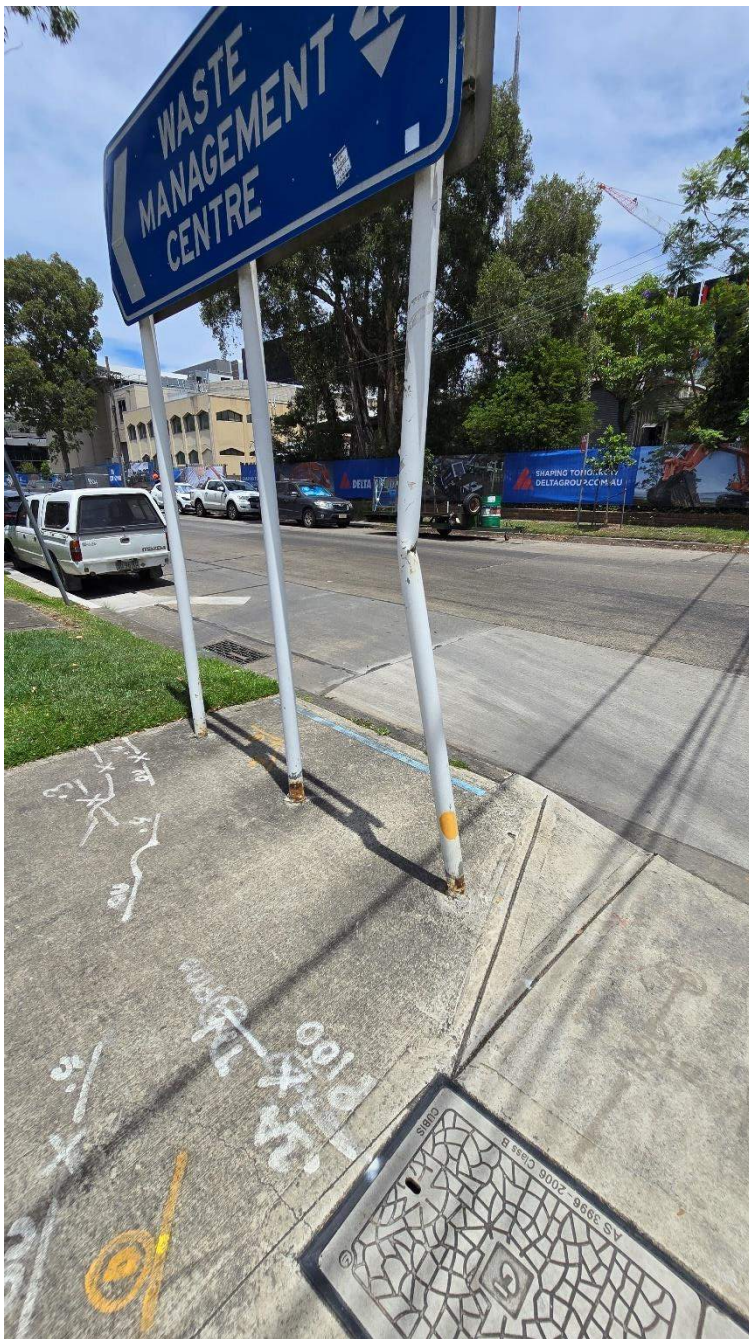
23. Photo: Cracks observed (31) - Sign has been struck and deformed - Refer to satellite image for location reference
24. Photo: Cracks observed (32, 33) - Road exhibits substantial joint sealant repairs, several cracks observed throughout road - Refer to satellite image for location reference

Figure 31 Cracks observed (31) - Sign has been struck and deformed

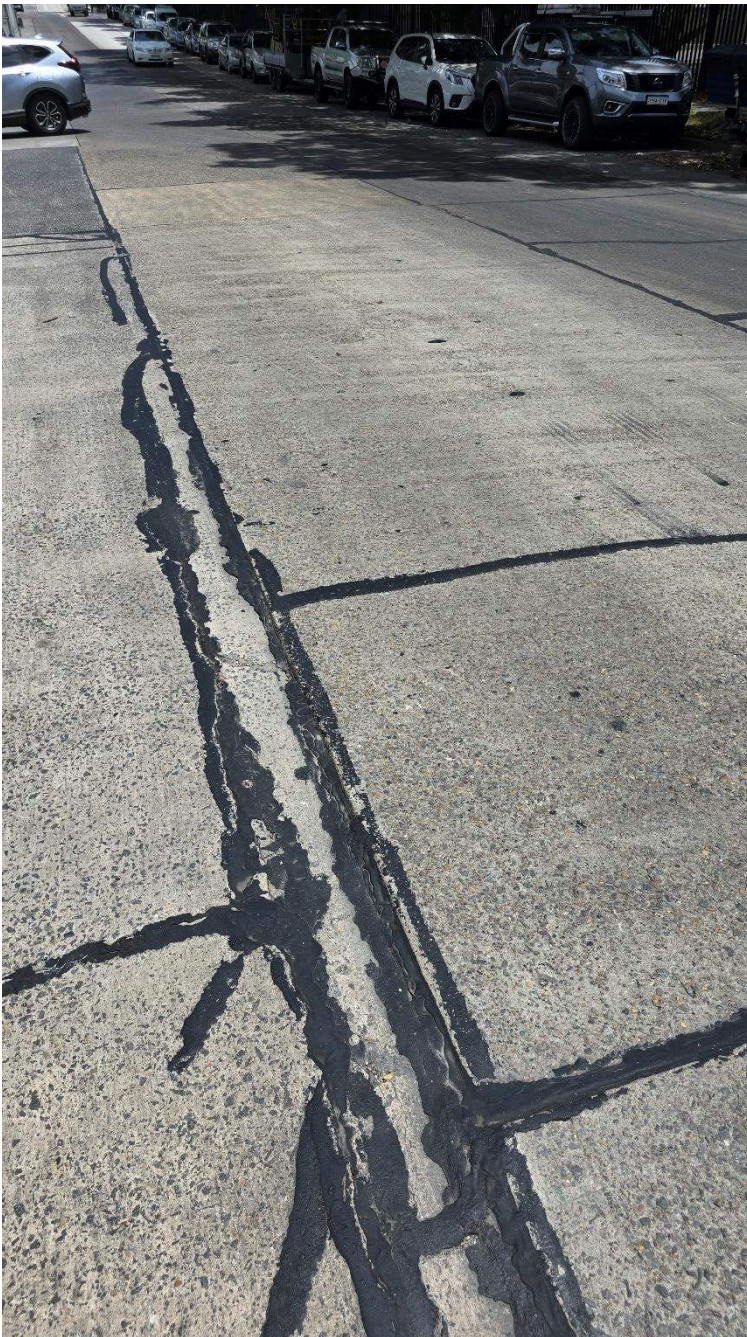
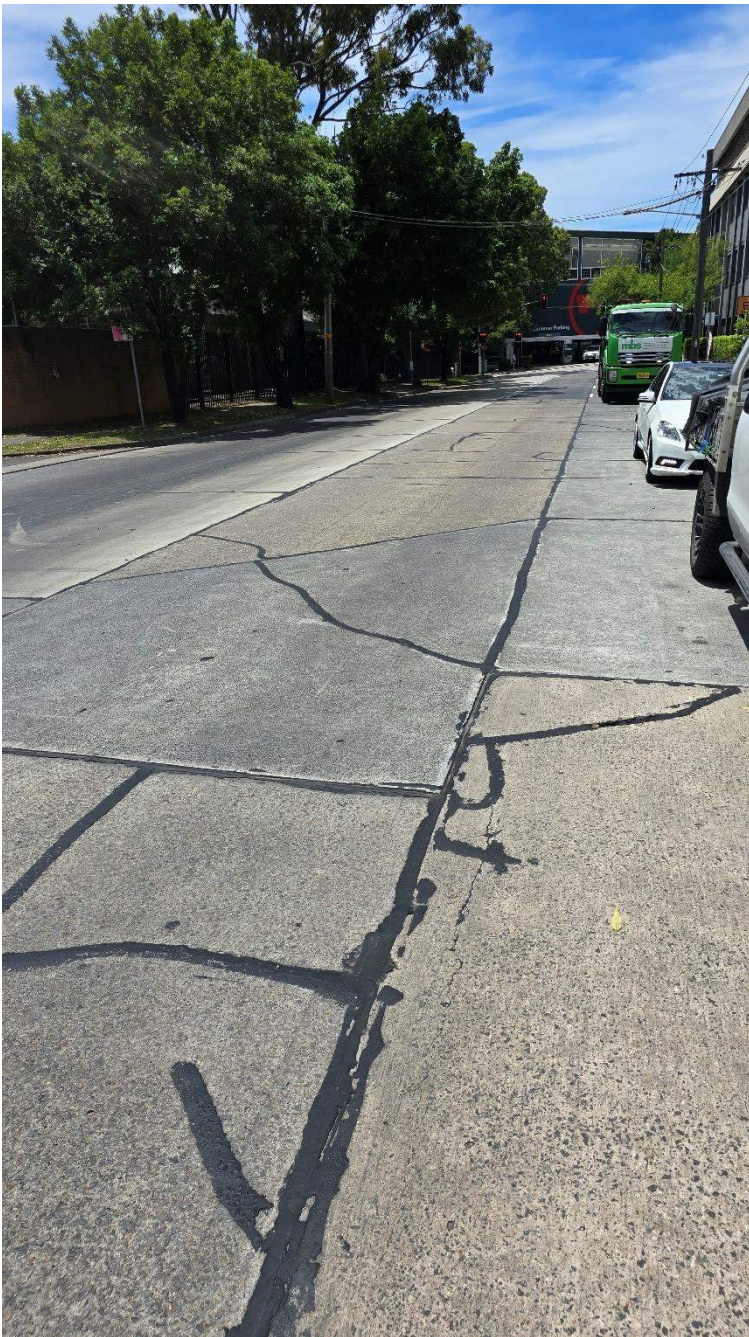
Figure 32 Cracks observed (32, 33) - Road exhibits substantial joint sealant repairs, several cracks observed throughout road

Figure 33 Cracks observed (32, 33) - Road exhibits substantial joint sealant repairs, several cracks observed throughout road

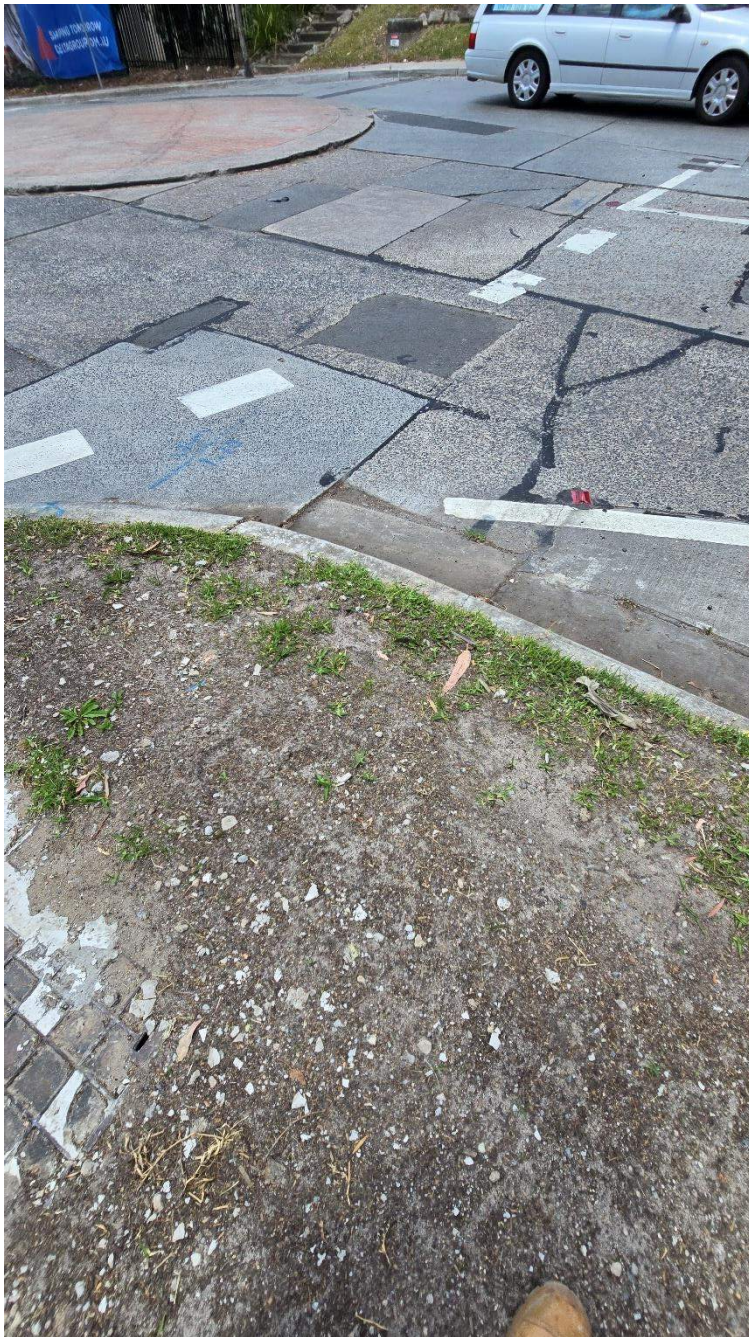
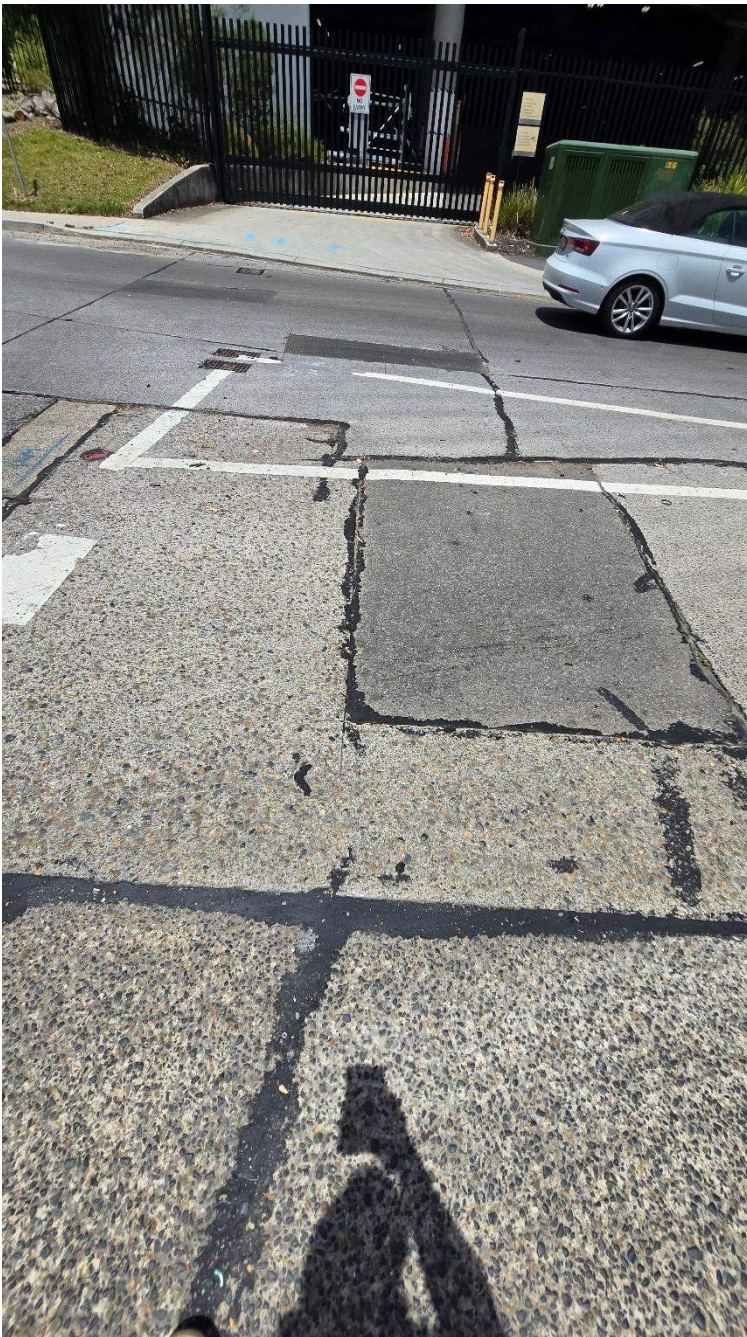
25. Photo: Cracks observed (34, 35) - Road exhibits substantial joint sealant repairs, several cracks observed throughout road - Refer to satellite image for location reference

Figure 34 Cracks observed (34, 35) - Road exhibits substantial joint sealant repairs, several cracks observed throughout road

Figure 35 Cracks observed (34, 35) - Road exhibits substantial joint sealant repairs, several cracks observed throughout road

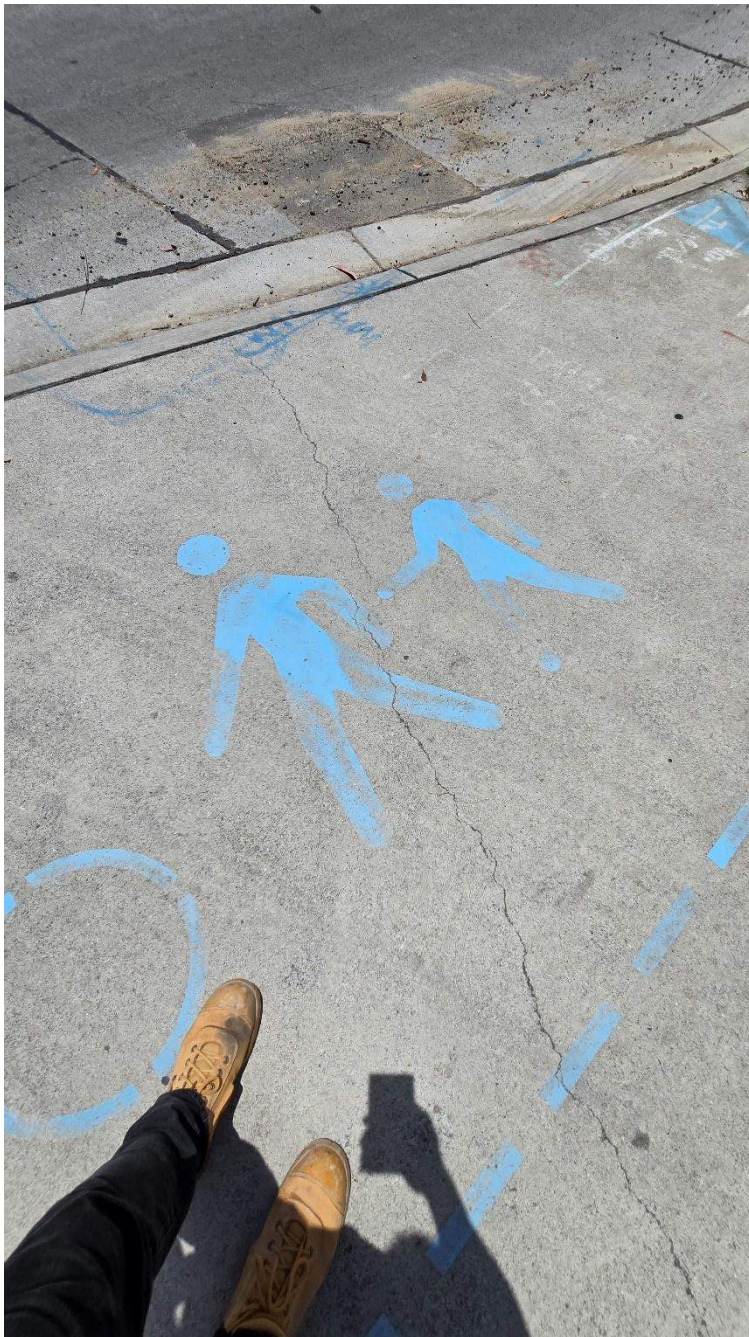
26. Photo: Cracks observed (36) - Surface breaks driveway - Refer to satellite image for location reference
27. Photo: Cracks observed (37, 38, 39) - Road exhibits substantial joint sealant repairs, several cracks observed throughout road - Refer to satellite image for location reference

Figure 36racks observed (36) - Surface breaks driveway

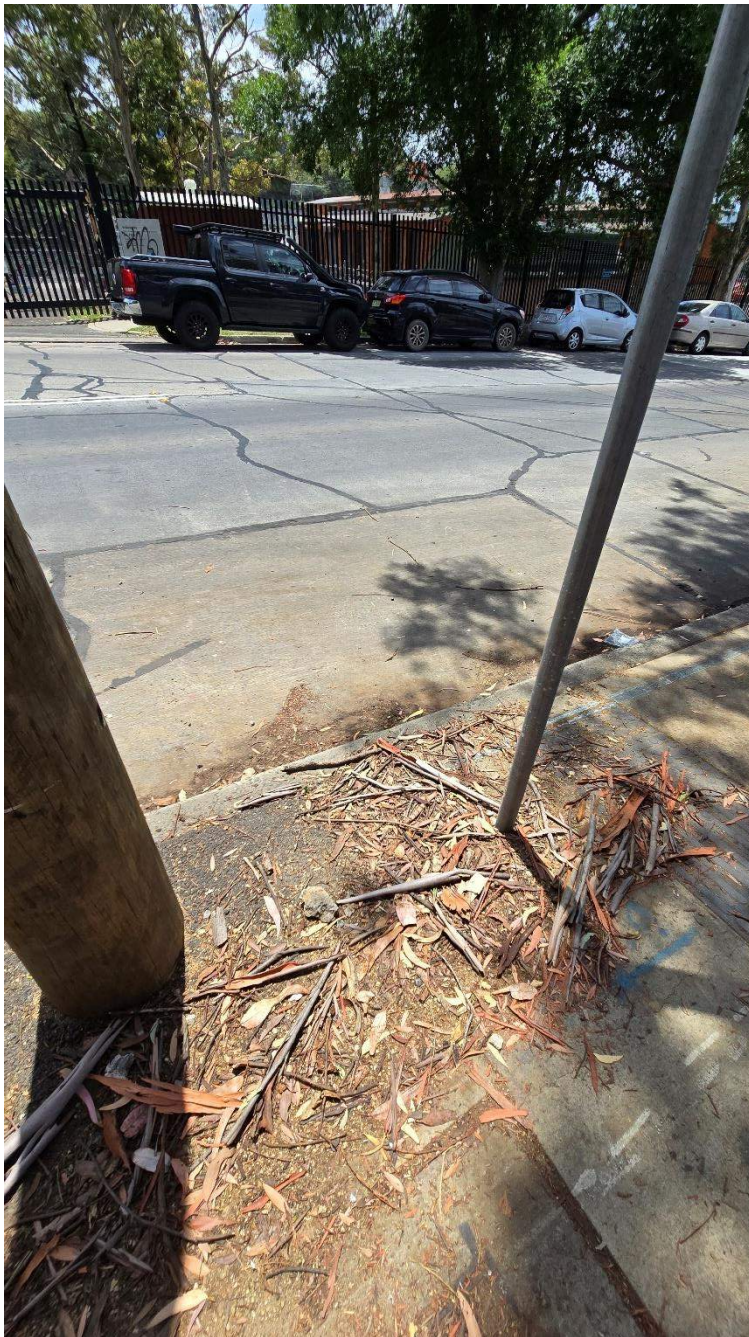
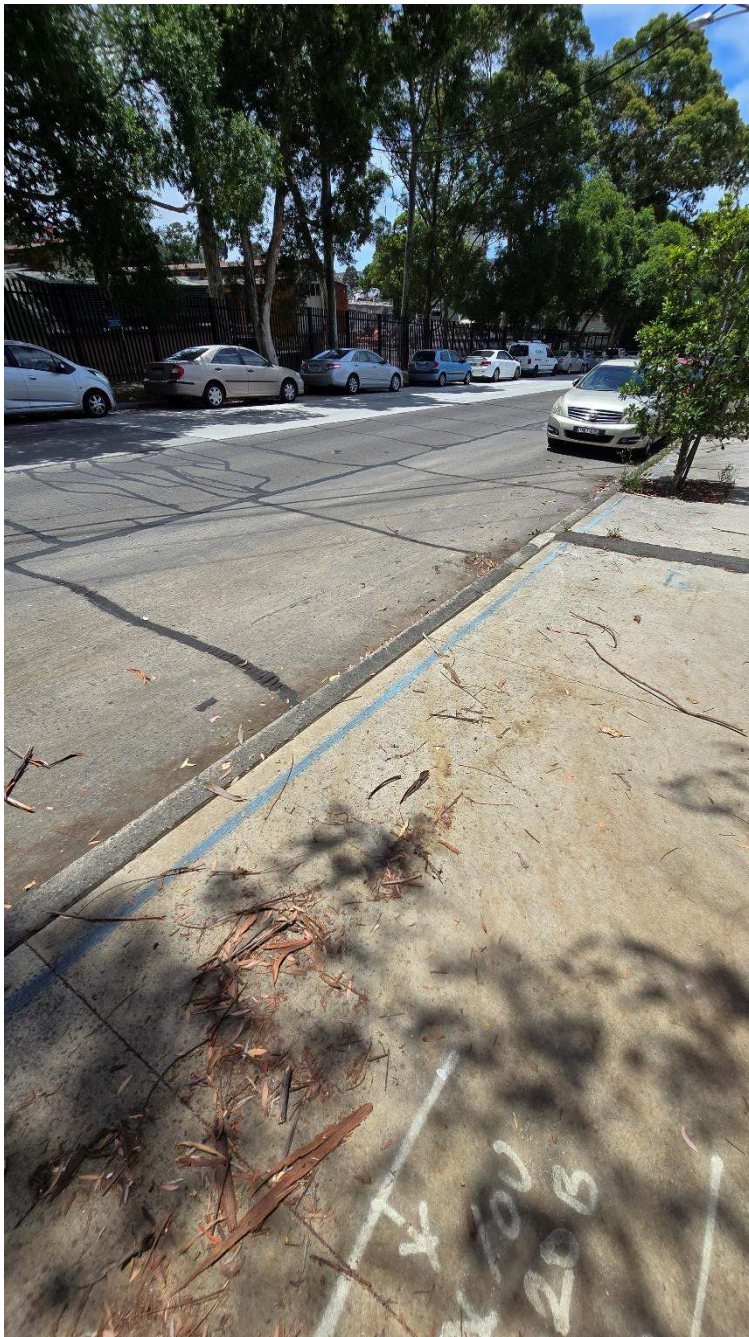
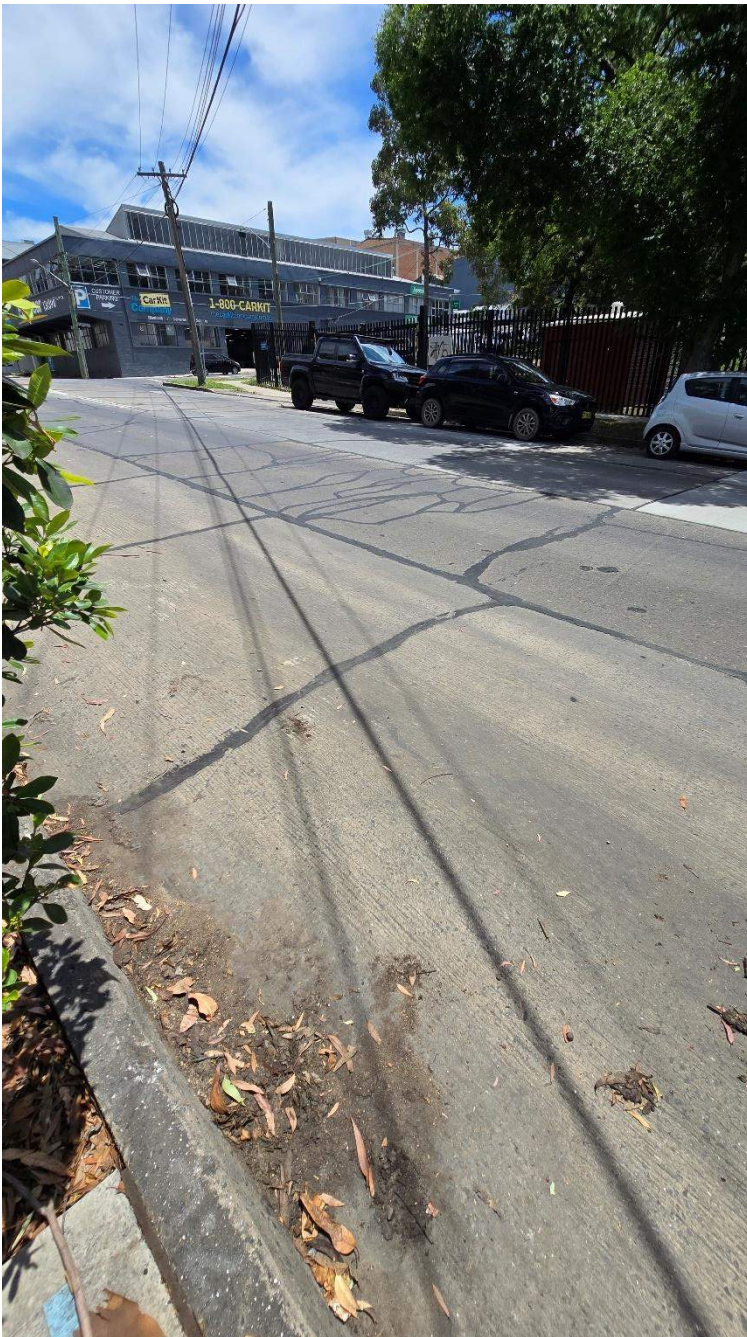
Figure 37 Cracks observed (37, 38, 39) - Road exhibits substantial joint sealant repairs, several cracks observed throughout road

Figure 38 Cracks observed (37, 38, 39) - Road exhibits substantial joint sealant repairs, several cracks observed throughout road

Figure 39 Cracks observed (37, 38, 39) - Road exhibits substantial joint sealant repairs, several cracks observed throughout road

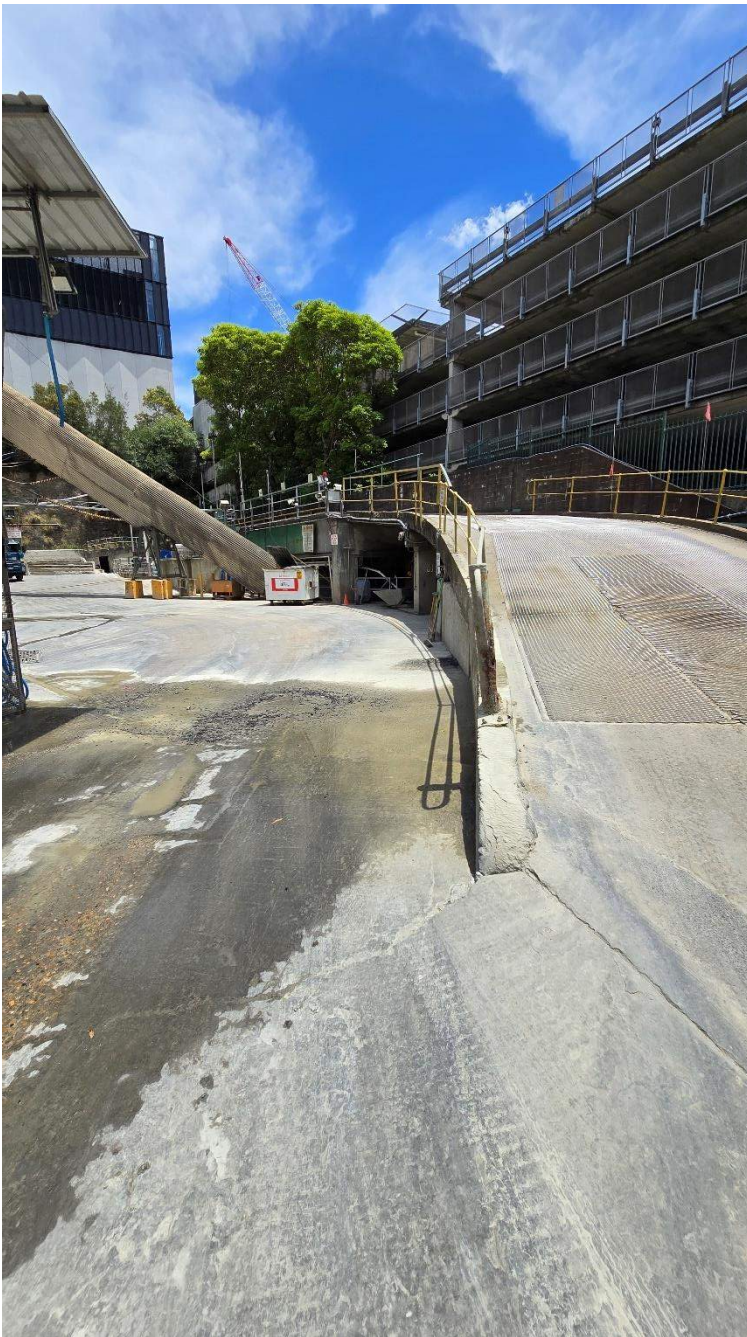
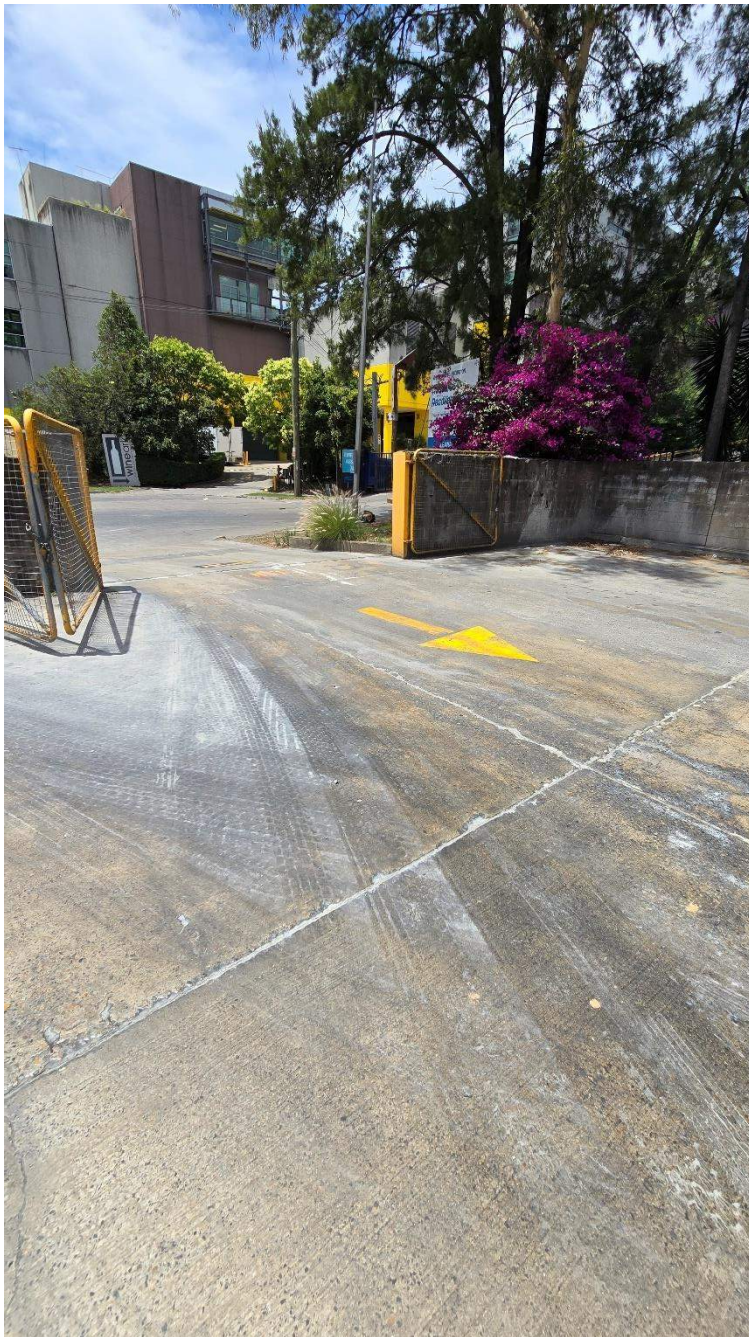
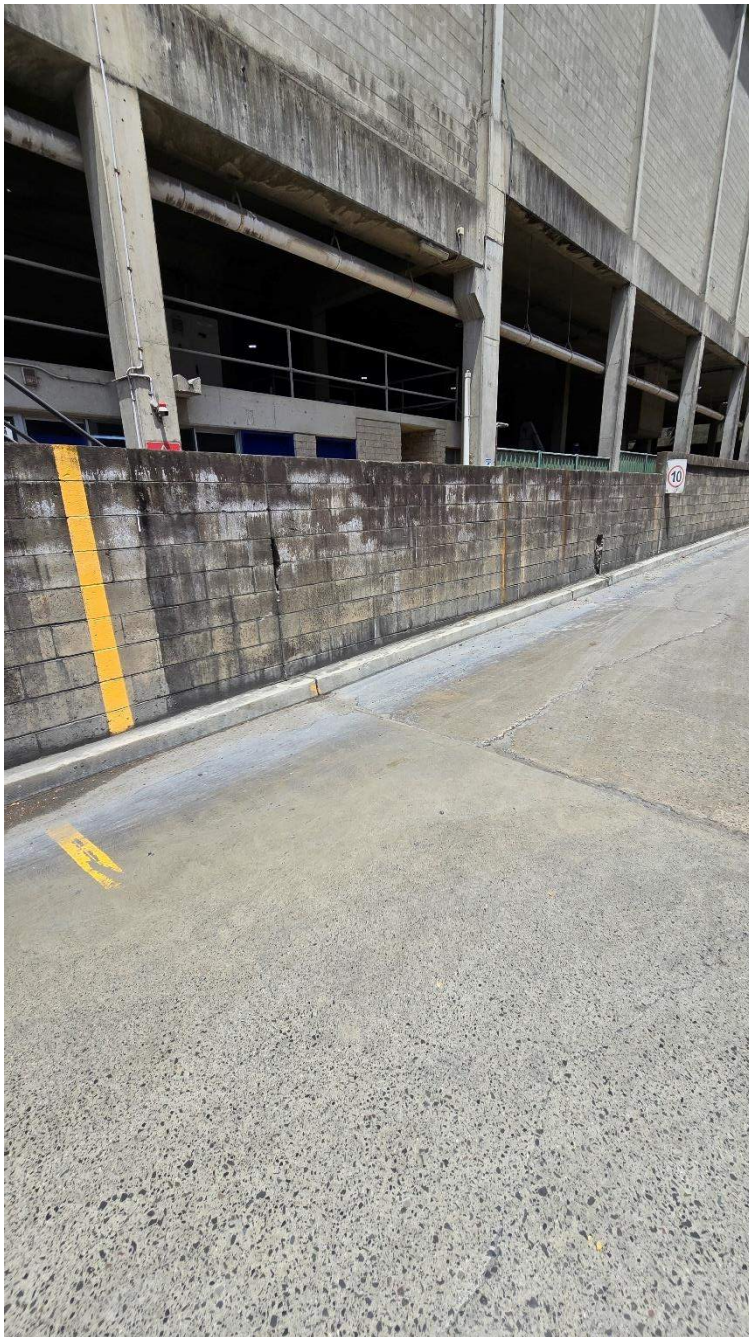
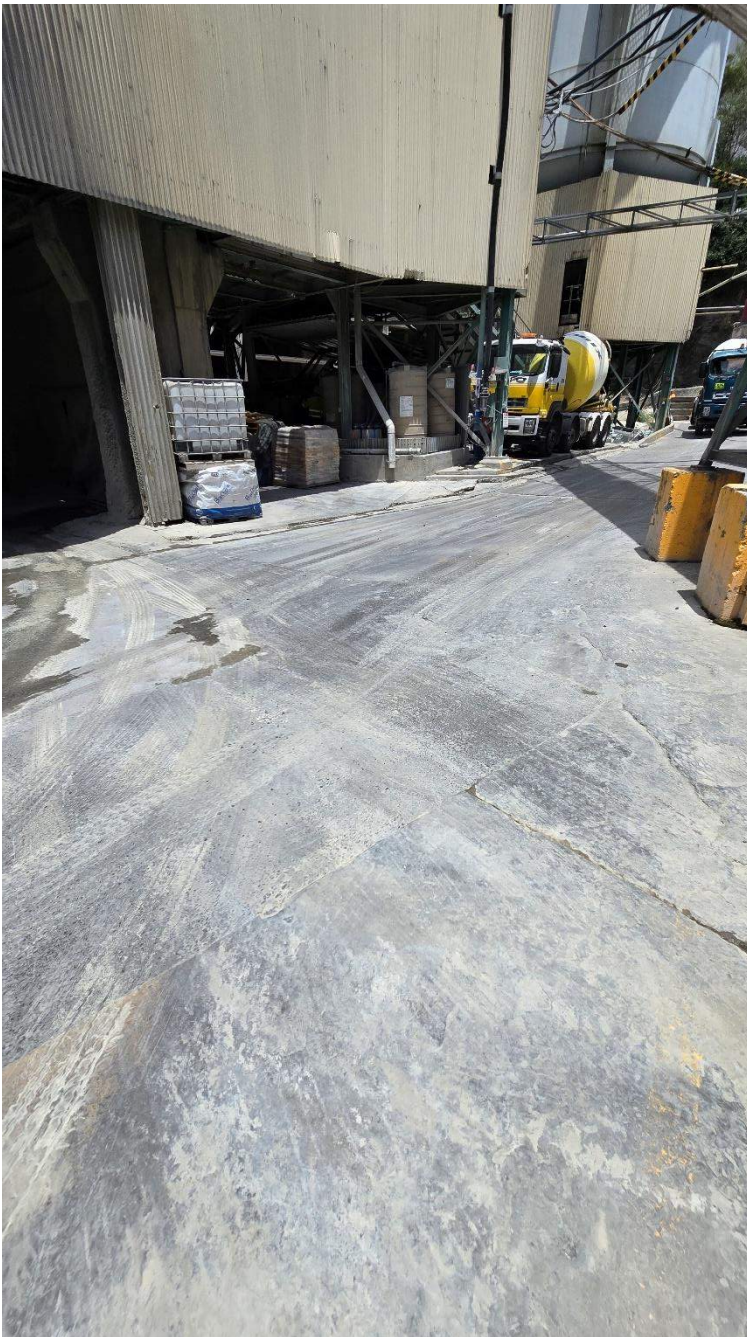
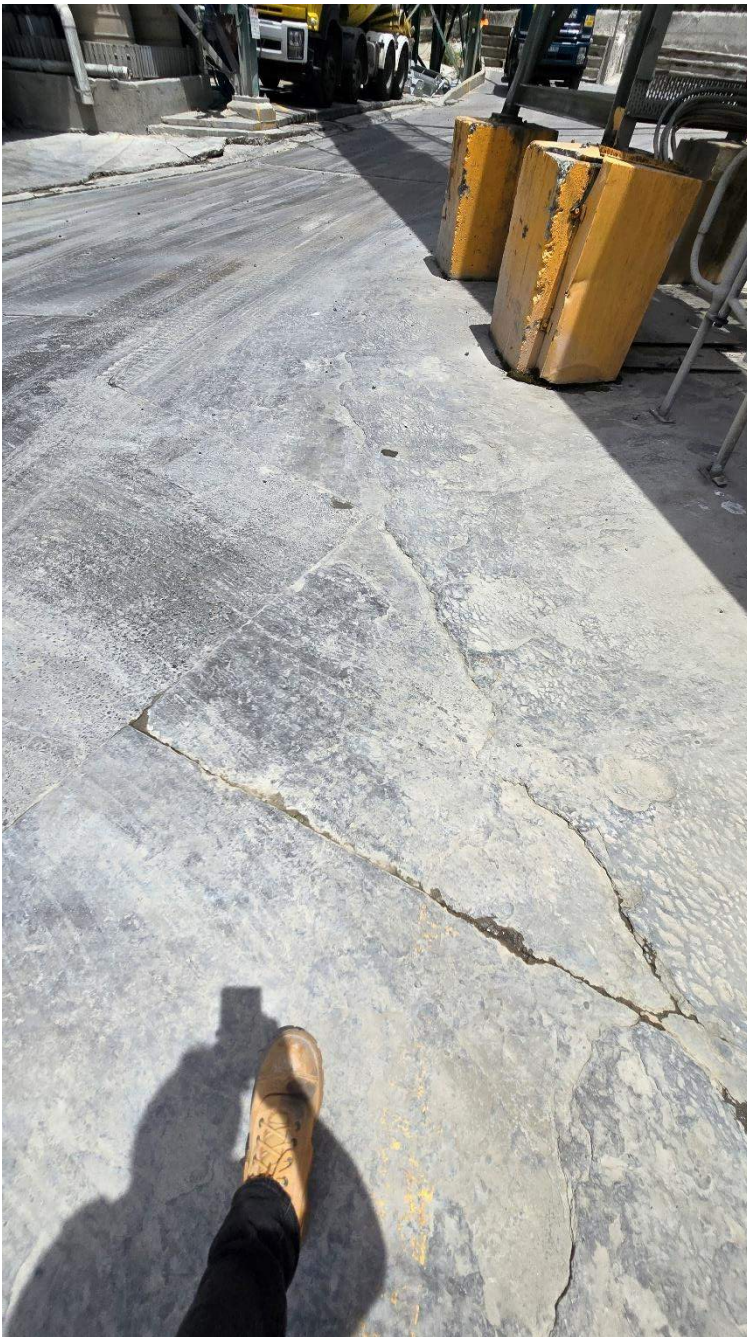
28. Photo: Cracks observed (40, 41, 42, 43, 44) - Concrete cracks throughout area - Refer to satellite image for location reference
29. Photo: Cracks observed (45) - Retaining wall large vertical crack - Refer to satellite image for location reference

Figure 40 Cracks observed (40, 41, 42, 43, 44) - Concrete cracks throughout area

Figure 41 Cracks observed (40, 41, 42, 43, 44) - Concrete cracks throughout area

Figure 42 Cracks observed (40, 41, 42, 43, 44) - Concrete cracks throughout area

Figure 43 Cracks observed (40, 41, 42, 43, 44) - Concrete cracks throughout area

Figure 44 Cracks observed (40, 41, 42, 43, 44) - Concrete cracks throughout area
