Pre-Construction Dilapidation Report of
The Surrounding Public area to 2 Lanceley Pl, Artarmon

Prepared For: Delta Pty Ltd

Project No.: 12.7.143.1

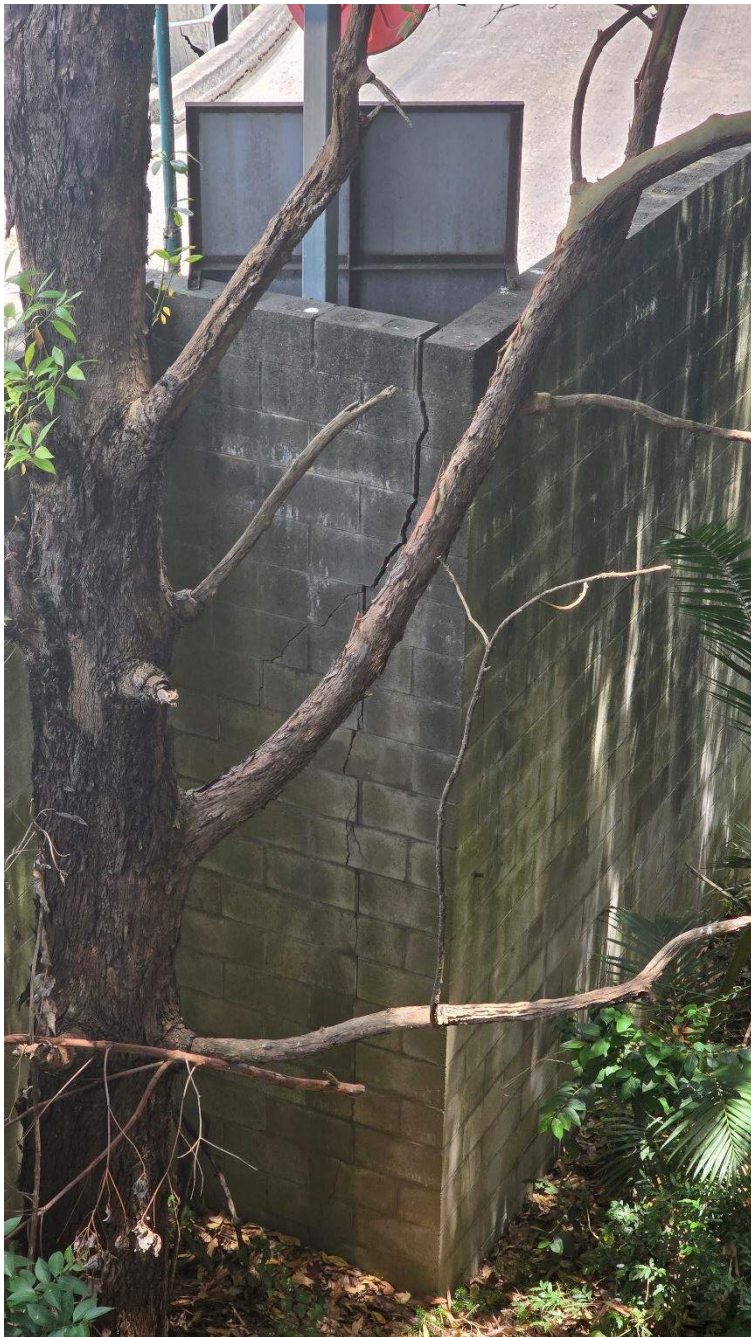
Figure 45 Cracks observed (45) - Retaining wall large vertical crack

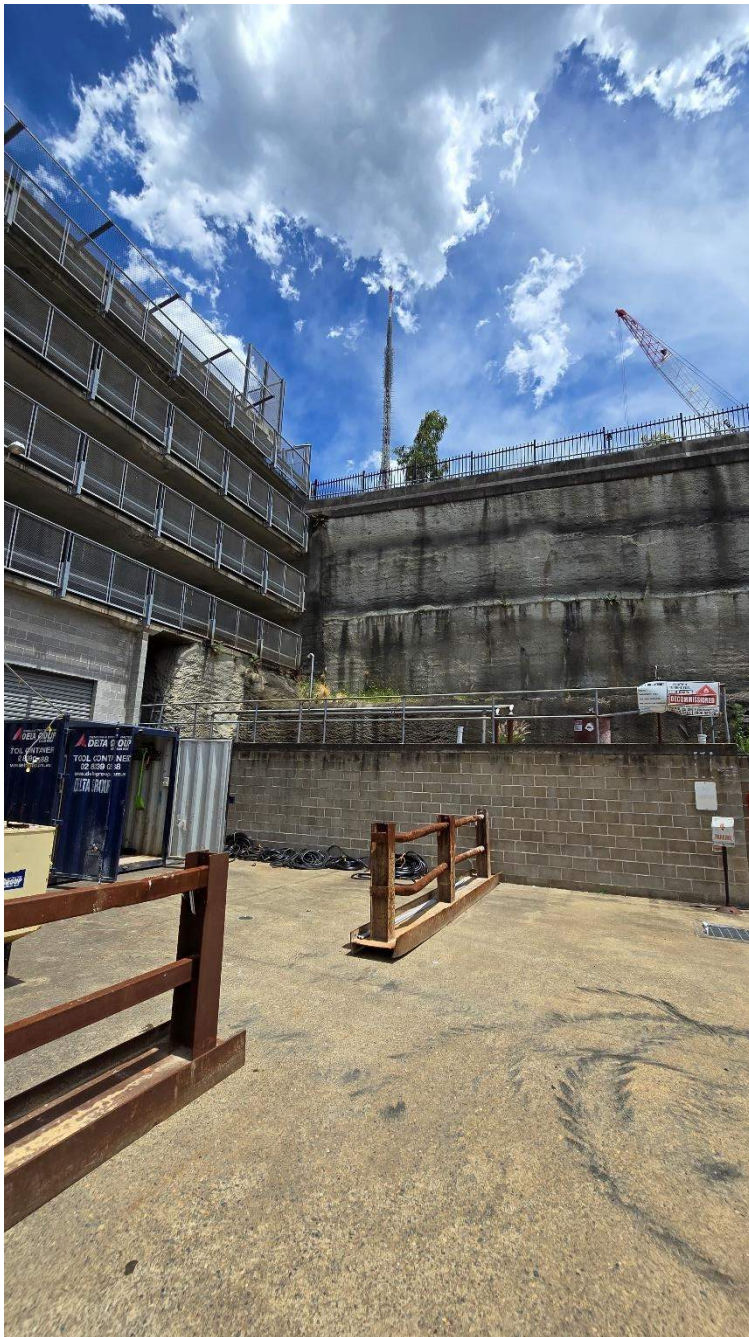
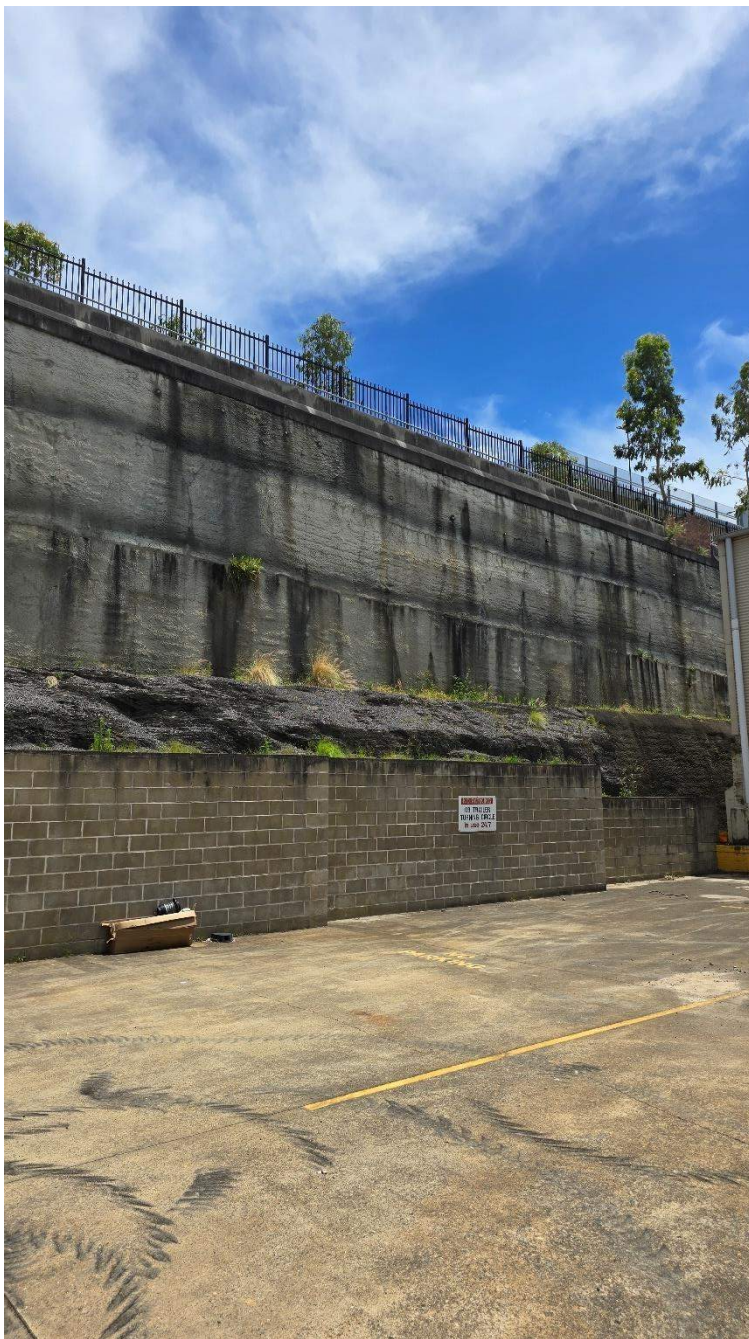
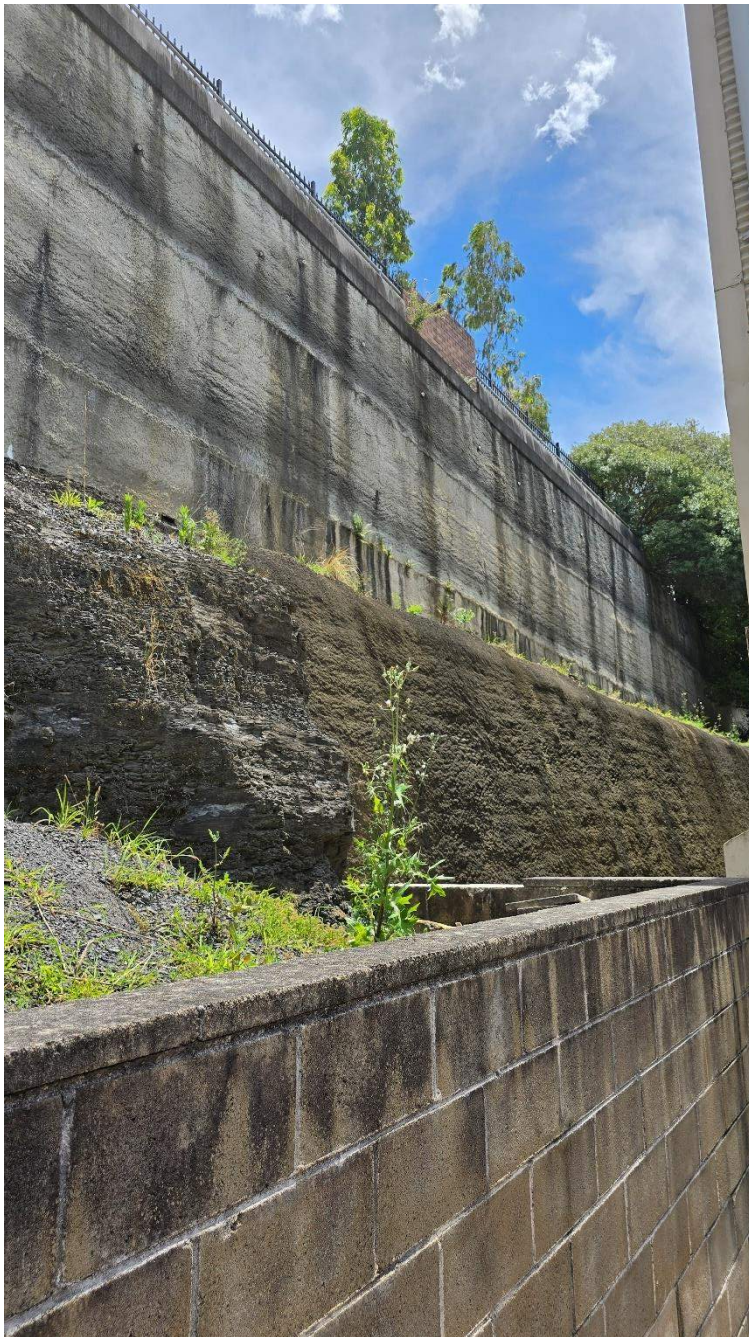
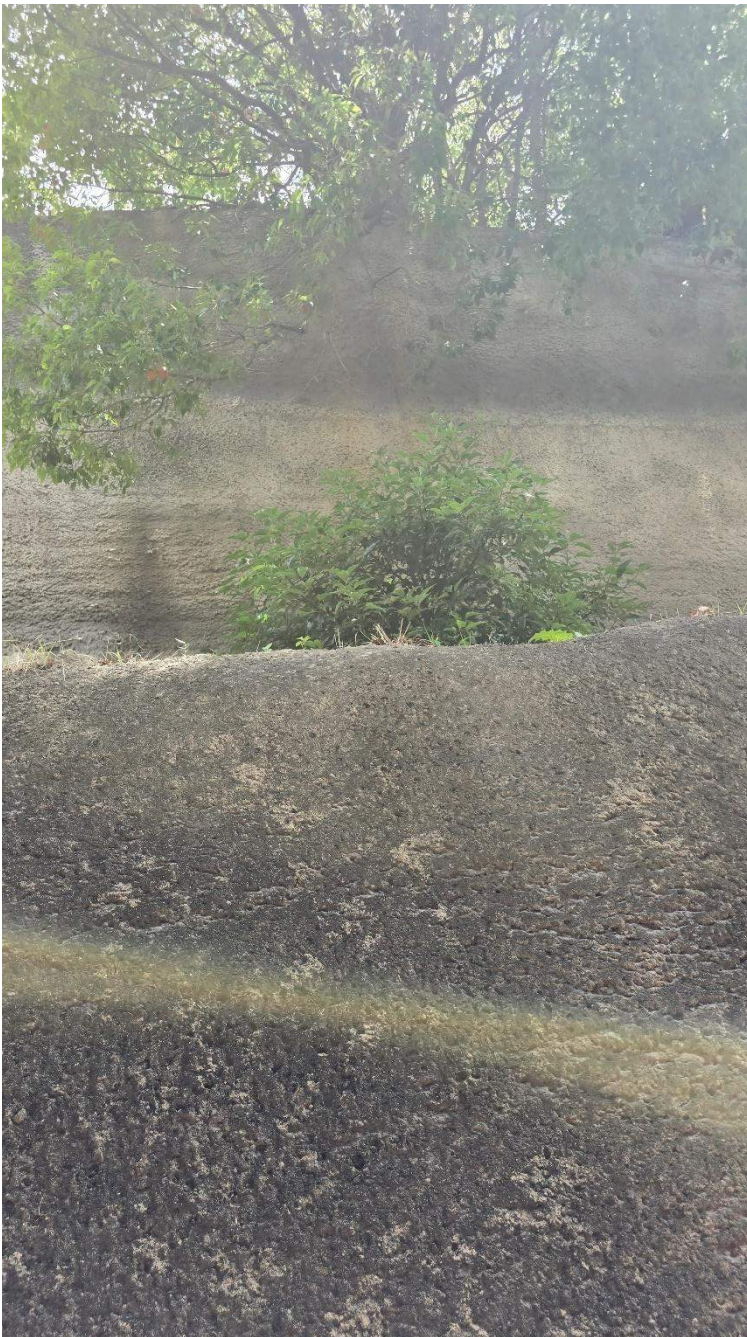
30. Photo: Cracks observed (46, 47, 48, 49) - Retaining wall exhibited signs of horizontal surface cracking - Refer to satellite image for location reference

Figure 46 Cracks observed (46, 47, 48, 49) - Retaining wall exhibited signs of horizontal surface cracking

Figure 47 Cracks observed (46, 47, 48, 49) - Retaining wall exhibited signs of horizontal surface cracking

Figure 48 Cracks observed (46, 47, 48, 49) - Retaining wall exhibited signs of horizontal surface cracking

Figure 49 Cracks observed (46, 47, 48, 49) - Retaining wall exhibited signs of horizontal surface cracking
