ErSed Reference: 19007-ERMR-52-231106

SSD 7348 - Oakdale West Industrial Estate (OWE)

Environmental Representative: Monthly Report (ERMR #52) – Revision 1

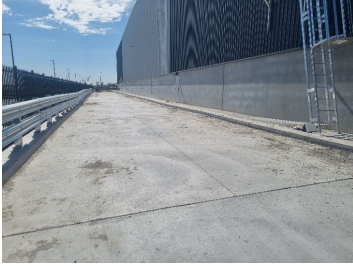
Photos and comments from inspections										
Photo	Date, Location & Comment									
 	<p>30 OCT 23 – ROADS</p> <p>Sediment is being tracked over the CAR</p> <p>Ongoing control of tracking to the CAR is required to mitigate transport to the estate roads.</p> <p>Sediment fence on the western side needs maintenance – this work is related to services works by others.</p>									
 	<p>30 OCT 23 – LOT 2CD</p> <p>Landscape works are progressing to the external areas.</p> <p>Services works are to be undertaken to the upper formation adjacent to the CAR. It is recommended that the top of batter to the landscaped areas is sealed with polymer or much to reduce sediment load to the new landscaped areas.</p> <p><u>Update 16 NOV 23</u></p>

<p>Inspection of the completed pavements and landscape areas confirm that material over pavements have been cleared.</p>

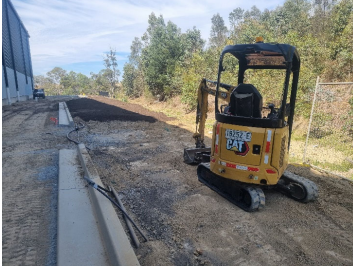
<p>30 OCT 23 – LOT 2CD</p> <p>Pavement works have been completed. This has left grit and sediment over the pavements. Sediment and grit over pavements is to be removed prior to hand over of the works.</p> <p>A final inspection will be undertaken for confirmation of clearing.</p> <p>Update 16 NOV 23</p> <p>Inspection of the completed pavements and landscape areas confirm that material over pavements have been cleared.</p>

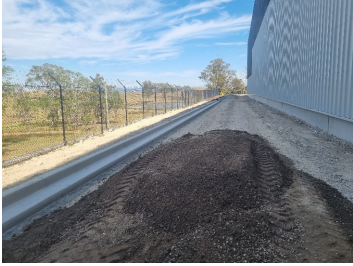
<p>30 OCT 23 – LOT 3CD</p> <p>The landscape area is progressing at the western boundary. This area will drain to the swale leading to the OSD and to Bakers Lane. Mulching and stabilization of this area should be a priority as it drains offsite. Coir logs or other controls may be provided within the swale as temporary sediment control pending completion of landscape works.</p> <p>Update 16 NOV 23</p> <p>Inspection of this area confirms</p>

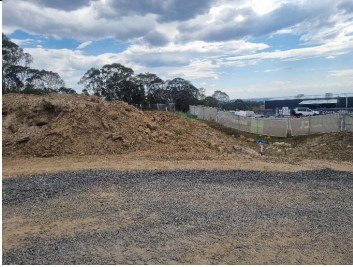
<p>30 OCT 23 – LOT 3CD</p> <p>Subgrade is being spread for the future asphalt works. The pits have been covered with plates.</p> <p>It was discussed that these pits have to be confirmed as closed or protected with sediment controls during works.</p> <p>Update 16 NOV 23</p> <p>Inspection of the area confirms</p>

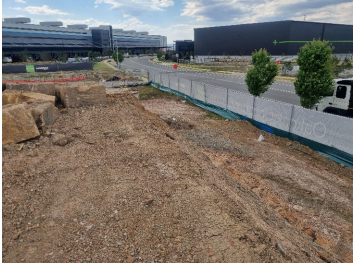
<p>30 OCT 23 – LOT 4AB</p> <p>Material has been stockpiled near to the head of the drainage swale from the CAR. Install sediment fence or a control bund between the stockpile and the swale.</p> <p>Update 16 NOV 23</p> <p>Inspection of the area confirms</p>

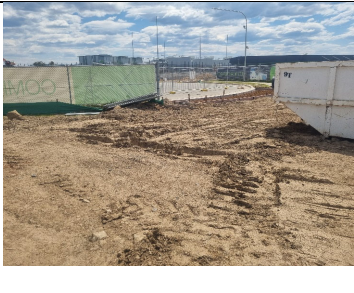
<p>30 OCT 23 – LOT 4CD</p> <p>A stockpile has been established at the side of the CAR – this material is from the surrounds of Lot 1A – this is to be removed from the site.</p> <p>Update 16 NOV 23</p> <p>Inspection of the area confirms</p>
