ErSed Reference: 19007-ERMR-46-230505

**SSD 7348 - Oakdale West Industrial Estate (OWE)**

**Environmental Representative: Monthly Report (ERMR #46)**

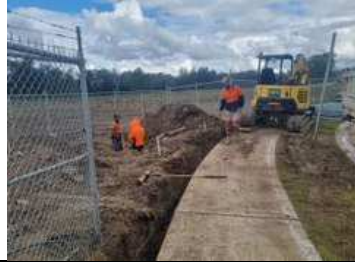
**LOT 5A/B – 03/04/23**

Both lots 5A and 5B a being undertaken by the same contractor and as such will be managed as one lot.

As such the contractor’s site facilities are set in the middle of the two areas.

Existing site surface controls are to be maintained so that the entire catchments of both lots 5A and 5B are reporting to the existing sediment control Basin located in the Northeast corner of the site.
