ErSed Reference: 19007-ERMR-43-230106

SSD 7348 - Oakdale West Industrial Estate (OWE)

Environmental Representative: Monthly Report (ERMR #43)

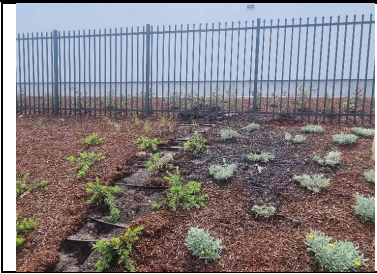
25 JAN 23 –LOT2A

A gap exists in the internal kerb.

Site water is directed over the batter and is damaging the landscaping.

The gap should be repaired, and the landscaping reinstated.
