ErSed Reference: 19007-ERMR-45-230407

SSD 7348 - Oakdale West Industrial Estate (OWE)

Environmental Representative: Monthly Report (ERMR #45)

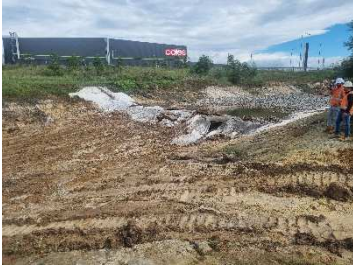
<p><u>24 MAR 23 – EB1</u> Estate basin 4 is holding water. The outlet area is stable. The inlet area on the western side is stable.</p>
