SSD 7348 - Oakdale West Industrial Estate (OWE)

Environmental Representative: Monthly Report (ERMR #21)

**SSD 7348 - Oakdale West Industrial Estate (OWE):
Environmental Representative Monthly Report (ERMR #21)
For the period 1 MAR to 31 MAR 2021**

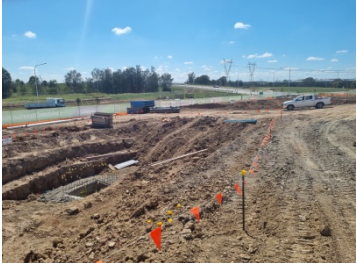
<p>Lot 1 A -4 MAR21</p> <p>Stormwater works are progressing close to the boundary of the site. It was discussed that the upper formation must be re shaped to that the catchment cannot pass out to the boundary.</p> <p>The sediment fence is only sufficient for the batter of the formation.</p>

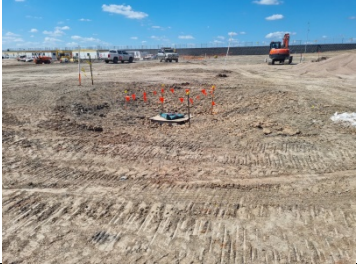
<p>Lot 1 A -4 MAR21</p> <p>Sediment control options at the site were discussed.</p> <p>It was confirmed that sediment control should be sufficient such that water passively leaving the project boundary should meet or attempt to meet the WQ standards indicated within the SWMP. If water is actively pumped from basins or storages these must meet the standards of the SWMP.</p> <p>In the context of when the basin may be removed it was discussed that as the works progress and more surfaces become stable (either slabs or roof areas) generating clean water these may be directed straight to stormwater while other works area may be stabilised with polymer or other treatments to further reduce the sediment load. As active works areas are reduced it may then be able to be demonstrated that maintenance of effective at pit controls may be appropriate to allow removal of the basin.</p> <p>This determination should be under the guidance of the contractors CPESC.</p>

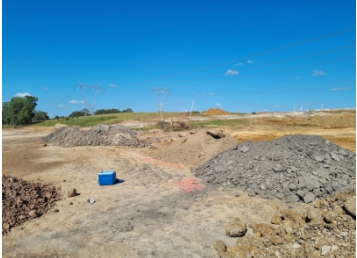
<p>OWIE Infrastructure -04 MAR 21</p> <p>Fill material is being imported into precinct 5. The material is coming from multiple locations.</p> <p>Stockpiles are being delivered as separate piles and the piles were being sampled as part of the material classification process.</p>
 	<p>OWIE Infrastructure -04 MAR 21</p> <p>A large temporary basin has been constructed in the upper formation. A spillway is provided to take water down the batter to the retaining wall works. An access track contracted to the lower works has weakened the dam wall to the north eastern corner.</p> <p>In the event of an overflow there is a chance that the wall will fail at this location and pass down the access track.</p> <p>It was discussed that in the event of a large rain event a large berm may be set across the head of the access track. The berm should be large enough to ensure the spillway is engaged.</p> <p>This arrangement should be inspected and confirmed by the Contractors CPESC.</p>

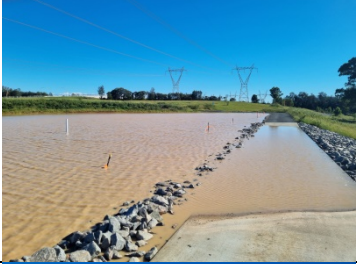
<p>OWIE Infrastructure –Post rain inspection 25 MAR 21</p> <p>Estate Basin 1 is full and overflowing.</p> <p>The basin is now overflowing post 300mm+ rainfall during the period.</p>
 	<p>OWIE Infrastructure –Post rain inspection 25 MAR 21</p> <p>The large temporary basin at Precinct 5 is full and has overflowed to the north.</p>

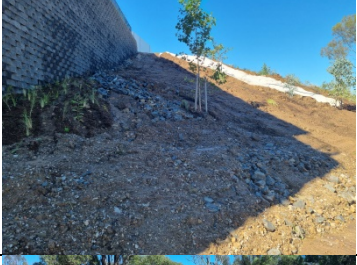
<p>OWIE Infrastructure –Post rain inspection 25 MAR 21</p> <p>The formal drainage structure from the rear of the retaining wall has failed in the heavy rains. It was confirmed that this structure had been completed and confirmed constructed in accordance with the design.</p>
 	<p>OWIE Infrastructure –Post rain inspection 25 MAR 21</p> <p>Bulk sediment from the failed area above has been detained within the rip rap channel from Estate Basin 2/3</p>
