SSD 7348 - Oakdale West Industrial Estate (OWE)

Environmental Representative: Monthly Report (ERMR #50)

Photos and comments from inspections	
Photo	Date, Location & Comment

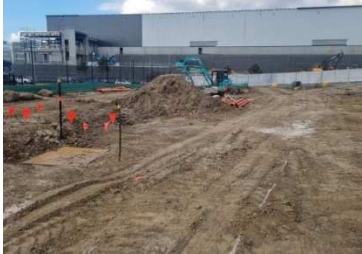
LOTS 4ABCD- 03/08/23 – INITIAL SITE INSPECTION

Both lots 4A and 4B a being undertaken by the same contractor AND with same superintendent and as such will be managed as one lot.

Currently the contractor’s site facilities are set at the top end of the cul-de sac from Road 6 (SEPIA AV)
Existing site surface controls are to be maintained so that the entire catchments of both lots report to the existing sediment control basin.

Controls are in place per that which was in place at hand over the contractor.
Items within the ESCP prepared for the development are yet to be fully implemented. – e.g., Sediment control at perimeter & wheel wash facilities.

It was confirmed that while the existing surface water management controls and Basin at the site are being maintained then this sediment control arrangement is appropriate for the risk at the site.

The priorities for management were discussed and confirmed. These include.

- Control of dust on an ongoing basis.
- Management of sediment tracking especially to estate roads
- Ensuring water does not pass to the swale at the side of the CAR – (THIS DRAINAGE LEADS OUT THE CONSTRUCTION AREA)
- Ongoing management and housekeeping of concrete waste, personal waste, and construction waste.

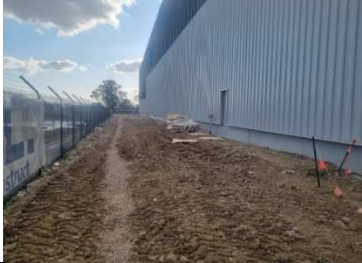
<p>LOT 2CD– 31/08/24</p> <p>It was questioned how this corner may be configured to allow construction of the primary access and lay back to Road 3.</p> <p>It was recommended that the available spoil material be used to shape the area adjacent to rd3, so a sufficient grade is achieved draining back into the main work area.</p> <p>Pits in this area should be closed to surface flows.</p> <p>Water the can then pond in the Northeast corner but removed from the eastern boundary.</p>
---	--

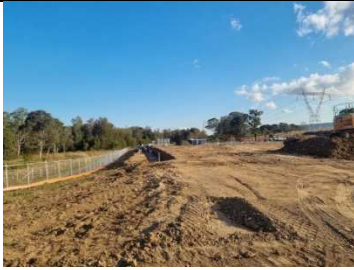
<p>LOT 2CD– 31/08/24</p> <p>It was indicated that sediment control has been removed from perimeter where the site has been shaped to drain back into the building area or where there is sufficient lip surrounded at the perimeter.</p> <p>Where water is directed to the newly installed stormwater, it was suggested that pits protections be improved or otherwise pits be comprehensively closed.</p>
---	---

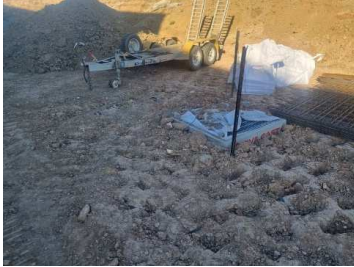
LOT 2CD– 31/08/24

Block wall works are progressing.
Only a limited catchment drains down to the perimeter sediment controls.
It was recommended that excess spoil be pulled back from the lower sediment control to improve its function.
Within the upper area- the surface should be shaped so that the primary catchments drain away from the perimeter and drain back into the central work area.

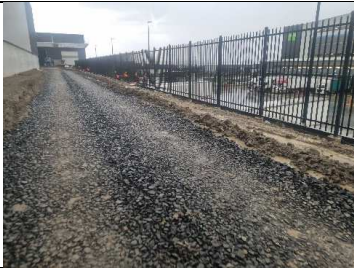
LOT 2CD– From previous month (31 JULY 23)

The Eastern stormwater works have been completed and as such this area is no longer available as a surface water storage.

30 AUG 23- closed

Works have progressed – see comments following
Sediment controls have been maintained/installed as requested.
Surfaces are being progressively prepared for asphalt works.

Sediment control should be installed and maintained around these pits in accordance with SD 6-12. See attached details.

Excess stockpiled material should be moved to Central designated stockpile areas and sealed off and smoothed.
