07 MAY 2024

**SSD 7348 - Oakdale West Industrial Estate (OWE)**

**Environmental Representative: Monthly Report (ERMR #58)**

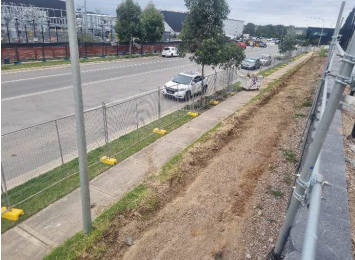
<p><u>30 APRIL 24 - 4A Site entrance control – western access</u></p> <p>The site access and surrounding sediment controls require maintenance.</p>
 	<p><u>30 APRIL 24 - 4A Eastern works areas</u></p> <p>The upper formation is being prepared for concrete works – a DGB/gravel base has been laid down.</p>

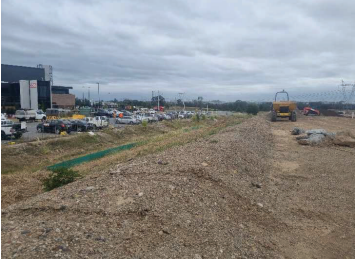
<p><u>30 APRIL 24 – 4B Northern boundary – below retaining wall.</u></p> <p>Sediment controls have been removed to allow for landscaping to progress. completion of the landscaping must be prioritised to stabilise these areas.</p>

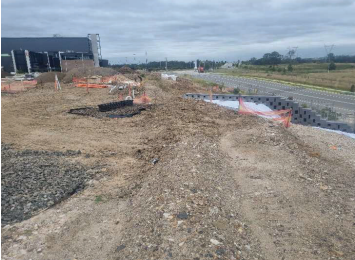
<p><u>30 APRIL 24 – 4D Western control berm</u></p> <p>The western control berm has been maintained. The sediment fence is maintained below the berm to accommodate the batter.</p>
