**SSD 7348 - Oakdale West Industrial Estate (OWE)**

**Environmental Representative: Monthly Report (ERMR #41)**

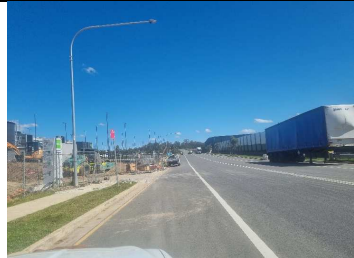
<p><u>29 NOV 22 – ROADS</u> Works are underway at the entrance to lot 2A – minor tracking is to be controlled at the layback to road 3</p>

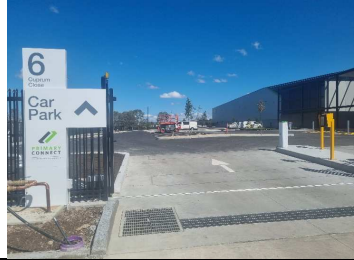
<p><u>29 NOV 22 – LOT4E</u> The car park has been sealed with bitumen and has been swept clear of sediment.</p>

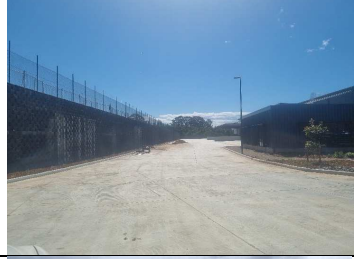
<p><u>29 NOV 22 – LOT3AB</u> Pavement and access ways have been finalised. Landscaping at back of kerb is progressing.</p>

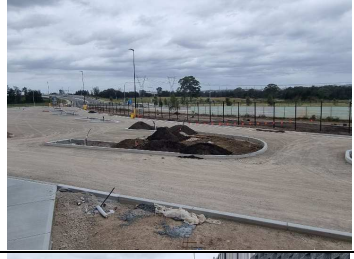
<p><u>30 NOV 22 – LOT3AB</u> The car park area to the east of the main pavements is being prepared for bitumen sealing  Landscaping work is being prepared at the back of kerb</p>

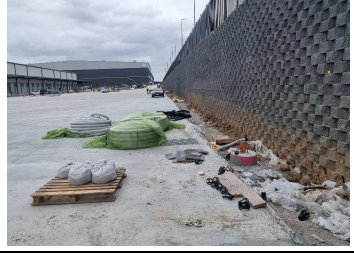
<p><u>30 NOV 22 – LOT2A</u> The main pavement has been completed. The edge kerb is yet to be installed.  It is suggested that bags be set at the rear of open kerb pits to separate the inlet from the landscaped areas especially where the landscape area is at the level of the pavement and sediment may flow to the pit.  House keeping in this area should be monitored.</p>
