ErSed Reference: 19007-ERMR-66-250116

SSD 7348 - Oakdale West Industrial Estate (OWE)

Environmental Representative: Monthly Report (ERMR #66)

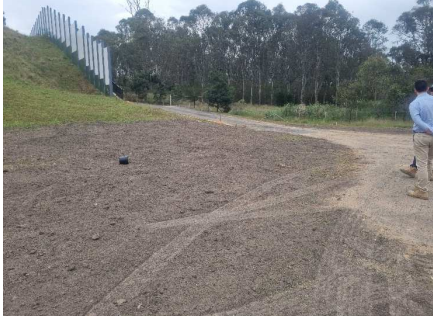
<p>Date, Location & Comment</p> <p>Site /stockpile area for Basin 2/3 conversion – Stockpile areas for placement of sediment from basin</p> <ul style="list-style-type: none"> Footprint of placement area is to be delineated Topsoil is then stripped to create control berm at toe of area. The control berm is protected with sediment fence and covered with geotextile Once placed – topsoil spread and treated with hydromulch Sediment fence to be retained until area is stabilised.

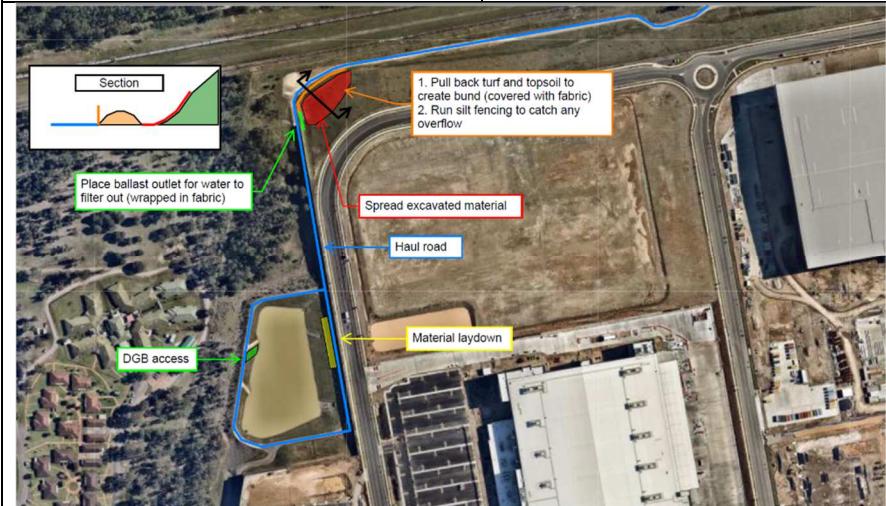
Works arrangement for Basin 2/3

15.	Closing Remarks	<p>Estate works are generally completed with only final conversion of the Main Estate basins outstanding.</p> <p>Updated Comments</p> <ul style="list-style-type: none"> The ER met with the estate contractor 4th December to review program, works method and location for controls at each basin. Work method plans and Layout were provided to the ER for review and to the Project CPESC for endorsement. Site lay out and method examples provided at 16 below.
-----	-----------------	--
