SSD 7348 - Oakdale West Industrial Estate (OWE)

Environmental Representative: Monthly Report (ERMR #74)

SSD 7348 - Oakdale West Industrial Estate (OWE):
Environmental Representative Monthly Report (ERMR #73)
For the period 1 AUGUST 2025 to 31 AUGUST 2025

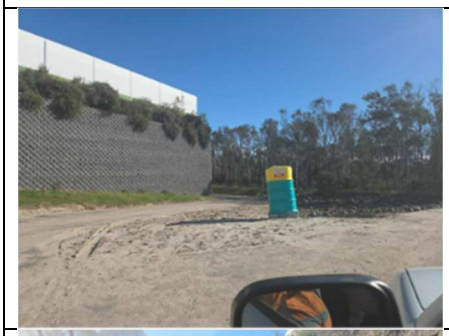
27 AUG 25 – Basin 2 and 3 access road Runoff from access track and external to sediment fence drains across the track towards WNSW pipeline and easement. A control is required at the outlet of the cross drain. Improvement to the management in this area is required. Update – 28 AUG 25 – Item confirmed with Burton Environmental Representative for action.
	 	27 AUG 25 – Basin 2 and 3 surrounds Western batter yet to be stabilised. Update – 28 AUG 25 – Item confirmed with Burton Environmental Representative as outstanding
