SSD 7348 - Oakdale West Industrial Estate (OWE)

Environmental Representative: Monthly Report (ERMR #72)

SSD 7348 - Oakdale West Industrial Estate (OWE):
Environmental Representative Monthly Report (ERMR #72)
For the period 1 JUNE 2025 to 30 JUNE 2025

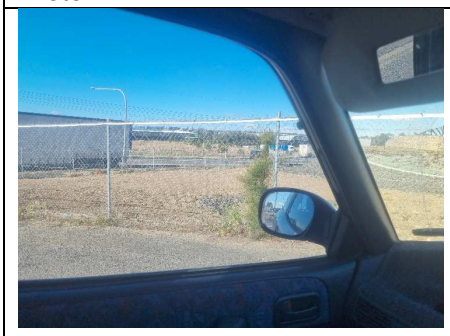
25 JUNE 25 Access road – northern end A portion of the area inside the chain link fence is yet to be stabilised.
