Pre-Construction Dilapidation Report of
The Surrounding Public area to 2 Lanceley Pl, Artarmon

Prepared For: Delta Pty Ltd

Project No.: 12.7.143.1

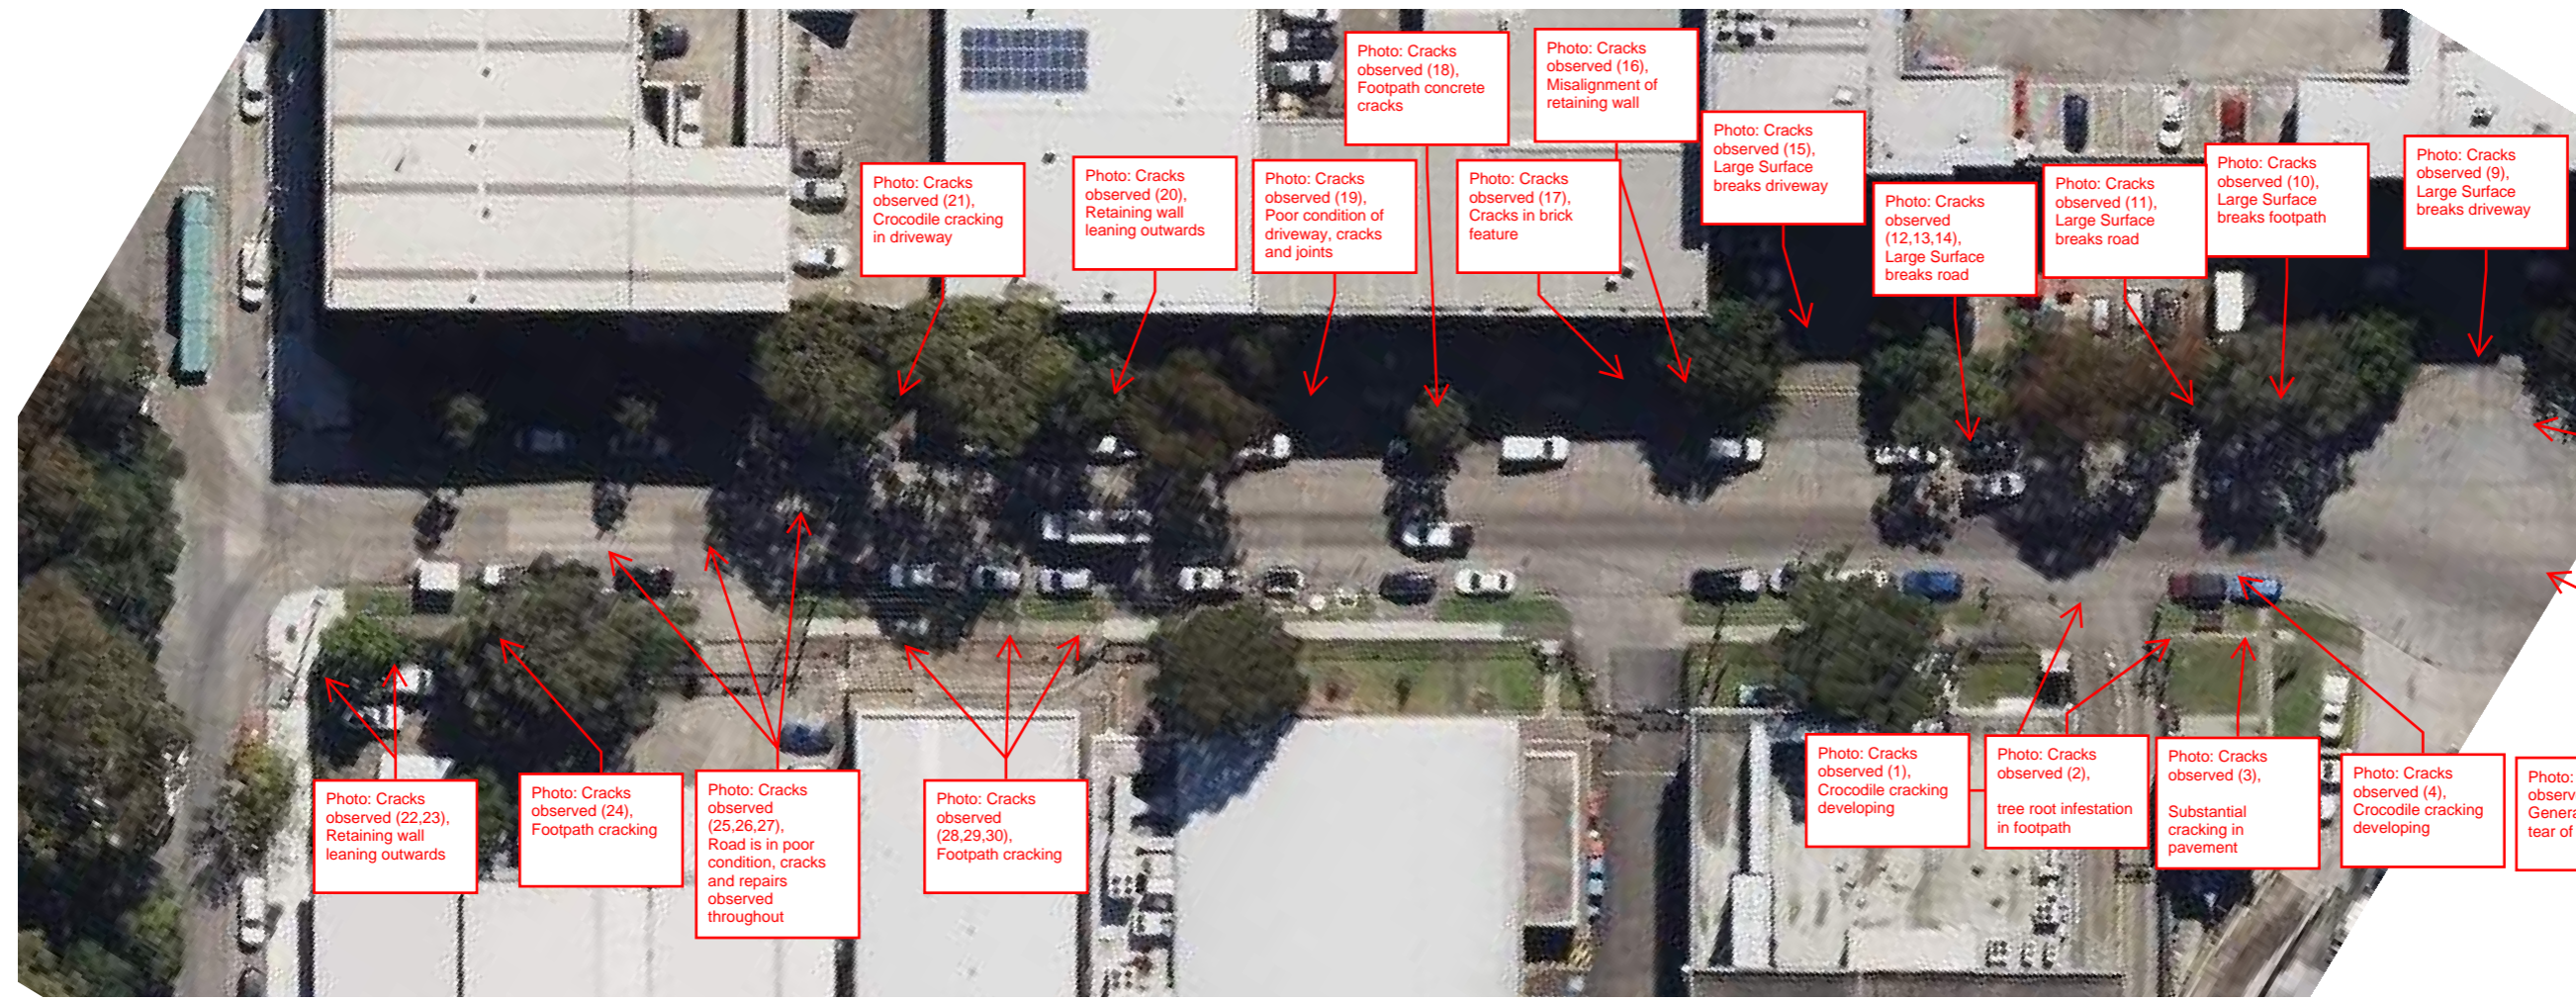
Photo: Cracks observed (22,23), Retaining wall leaning outwards

Photo: Cracks observed (24), Footpath cracking

Photo: Cracks observed (25,26,27), Road is in poor condition, cracks and repairs observed throughout

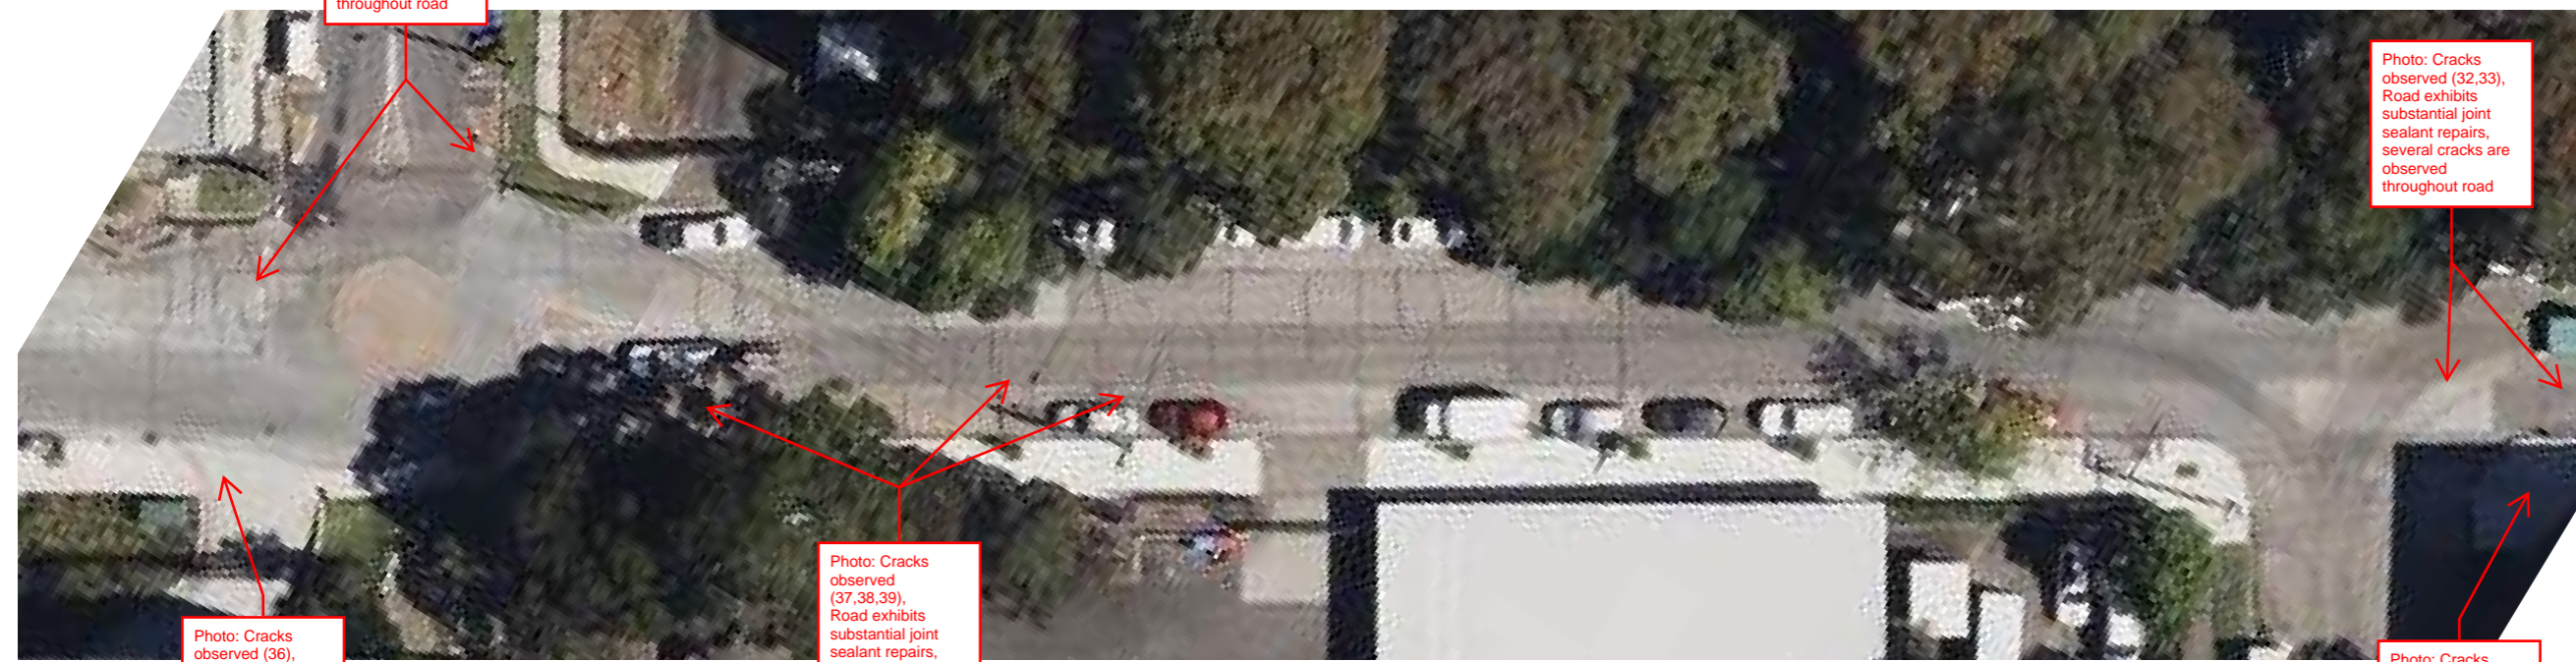
Photo: Cracks observed (36), Surface breaks driveway

Photo: Cracks observed (31), Sign has been struck and deformed.

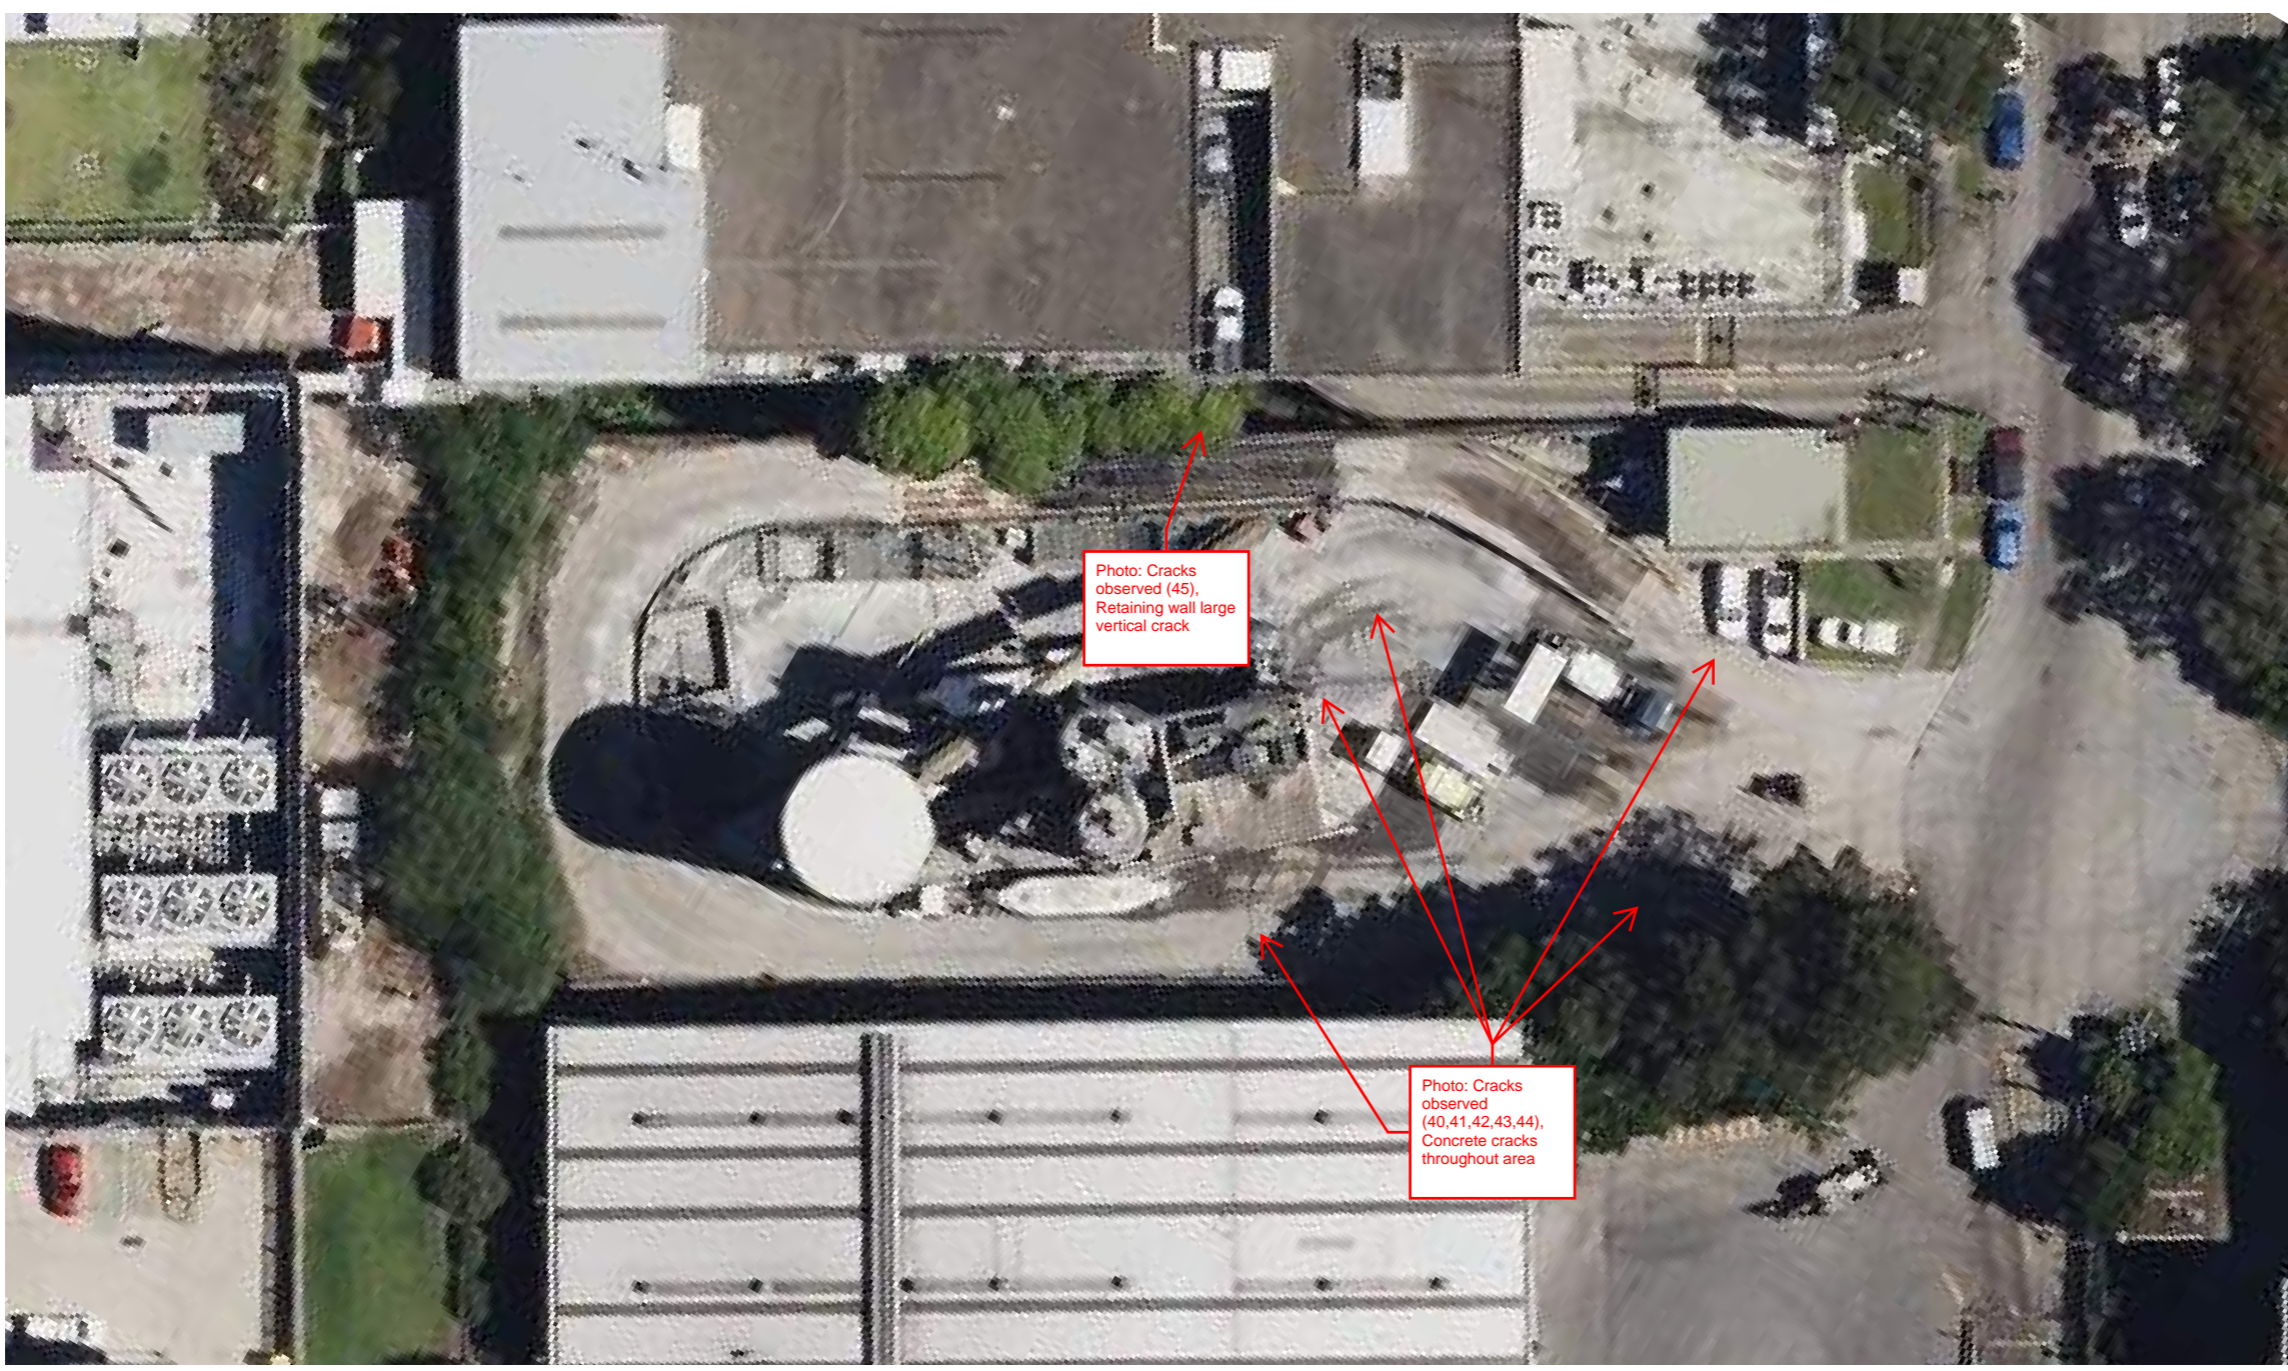
Photo: Cracks observed (45), Retaining wall large vertical crack

Photo: Cracks observed (40,41,42,43,44), Concrete cracks throughout area

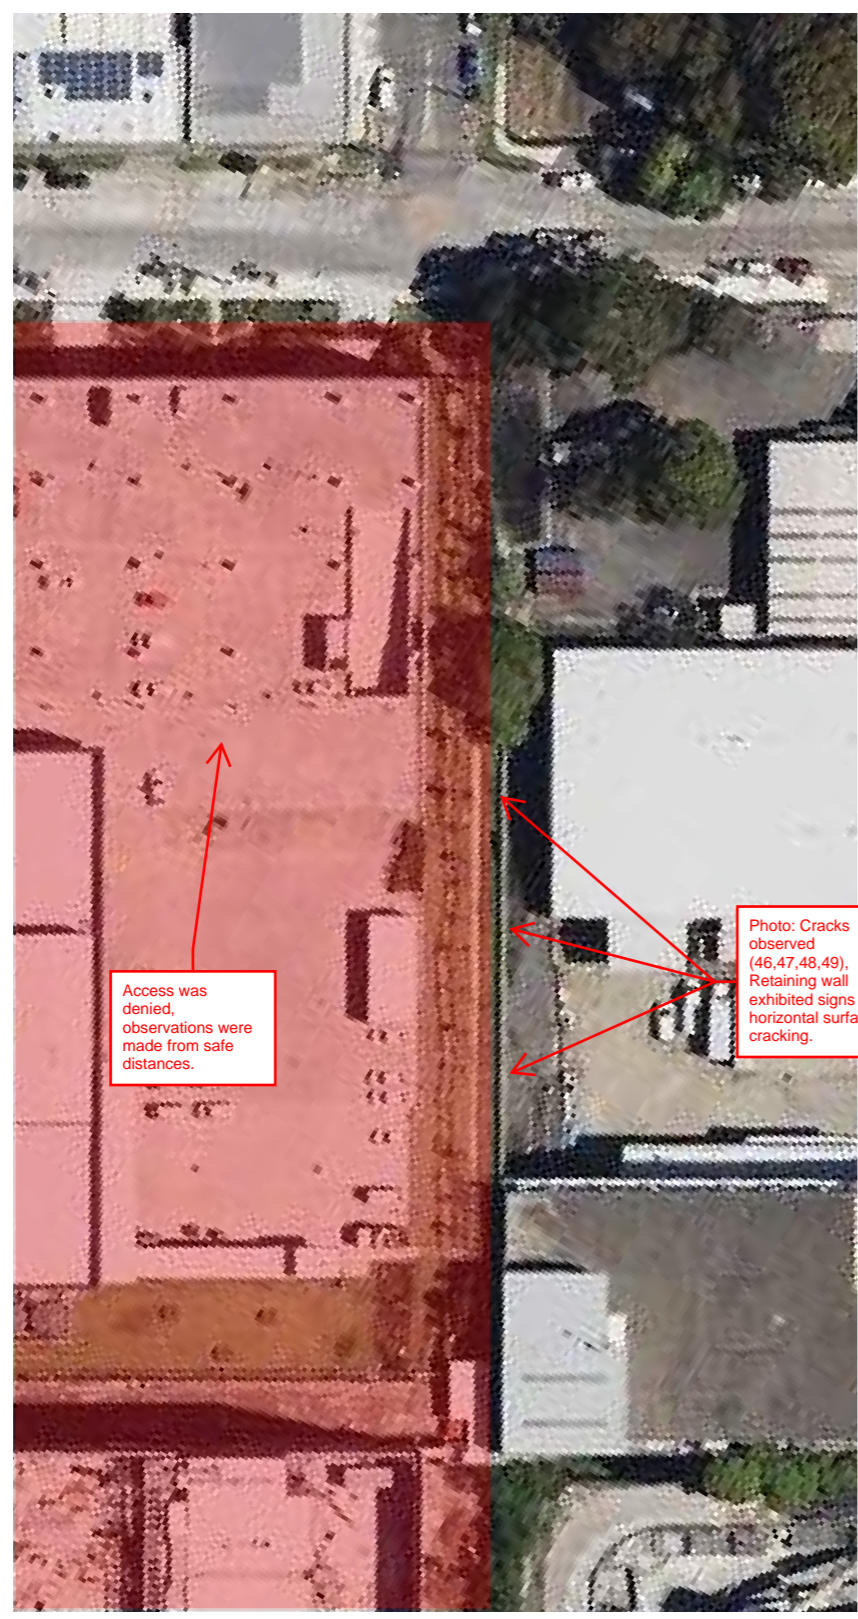
Access was denied, observations were made from safe distances.

Photo: Cracks observed (46, 47, 48, 49), Retaining wall exhibited signs of horizontal surface cracking.
