SSD 7348 - Oakdale West Industrial Estate (OWE)

Environmental Representative: Monthly Report (ERMR #68)

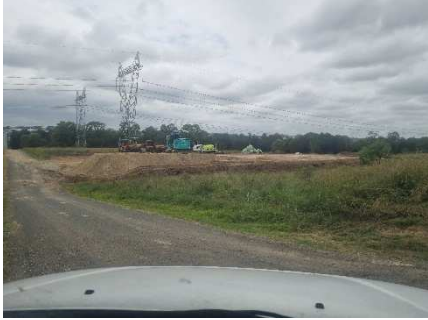
<p><u>20 FEB 25 Basin 5- stockpile area</u> Controls are in place per previous inspection with shaped topsoil material pushed to the sides to isolate the stockpile area.</p>

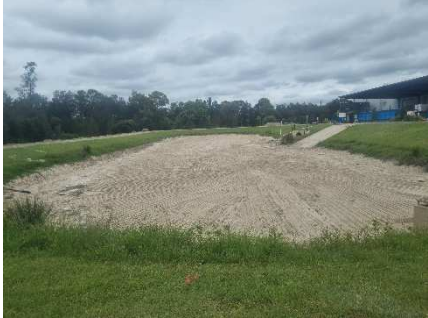
<p><u>20 FEB 25 Basin 5</u> The internals to the basin have been completed to the operational drainage form.</p>

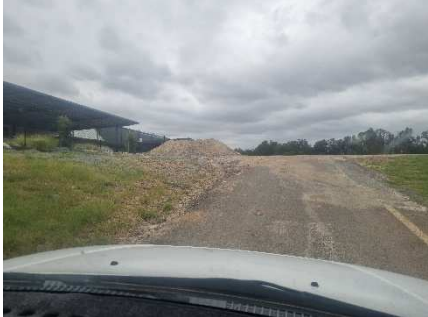
<p><u>20 FEB 25 Basin 5</u> A small stockpile of material is located in the Southwest corner of Basin 5.</p> <p>This material should be removed to a formal stockpile area as it is part of a catchment draining away from the basin and sediment controls.</p>

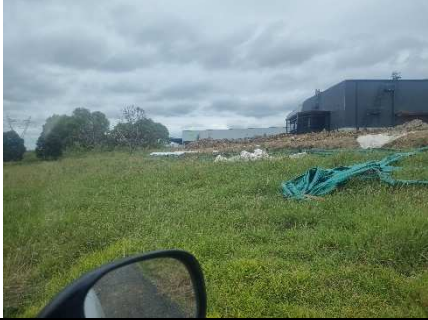
<p><u>20 FEB 25 Basin 4 and surrounds</u></p> <p>Maintenance is required to the sediment controls below the stockpile material.</p>

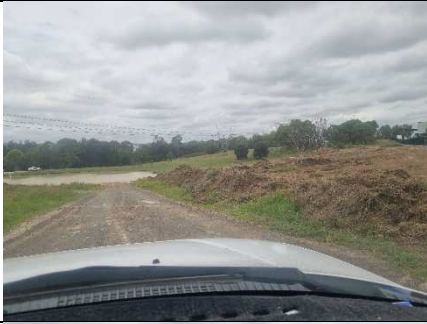
20 FEB 25 Stockpile area above basin 4

Additional windrowed material has been placed on the southern side of the stockpile area adjacent to the access track.

This material should be shaped and allowed to revegetate or otherwise seeded

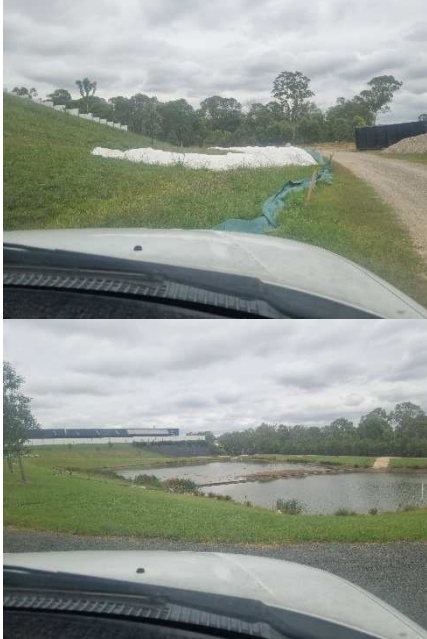
20 FEB 25 Works for Basin 2-3

The control bund below the stockpile area has been maintained. Minor maintenance to the sediment fence should be undertaken.

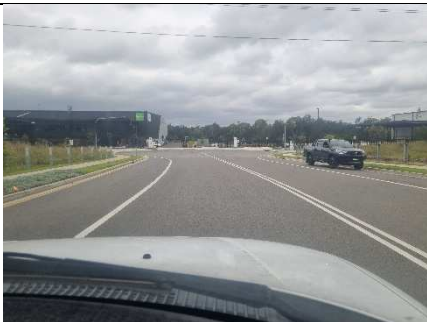
20 FEB 25 Roadways – Road 6

The road area is swept and clear of sediment
